# A highlight from the Penobscot Bay Working Waterfront Resiliency NOAA Project of Special Merit

# Public Landing, Belfast, ME

# Structural Deficiencies

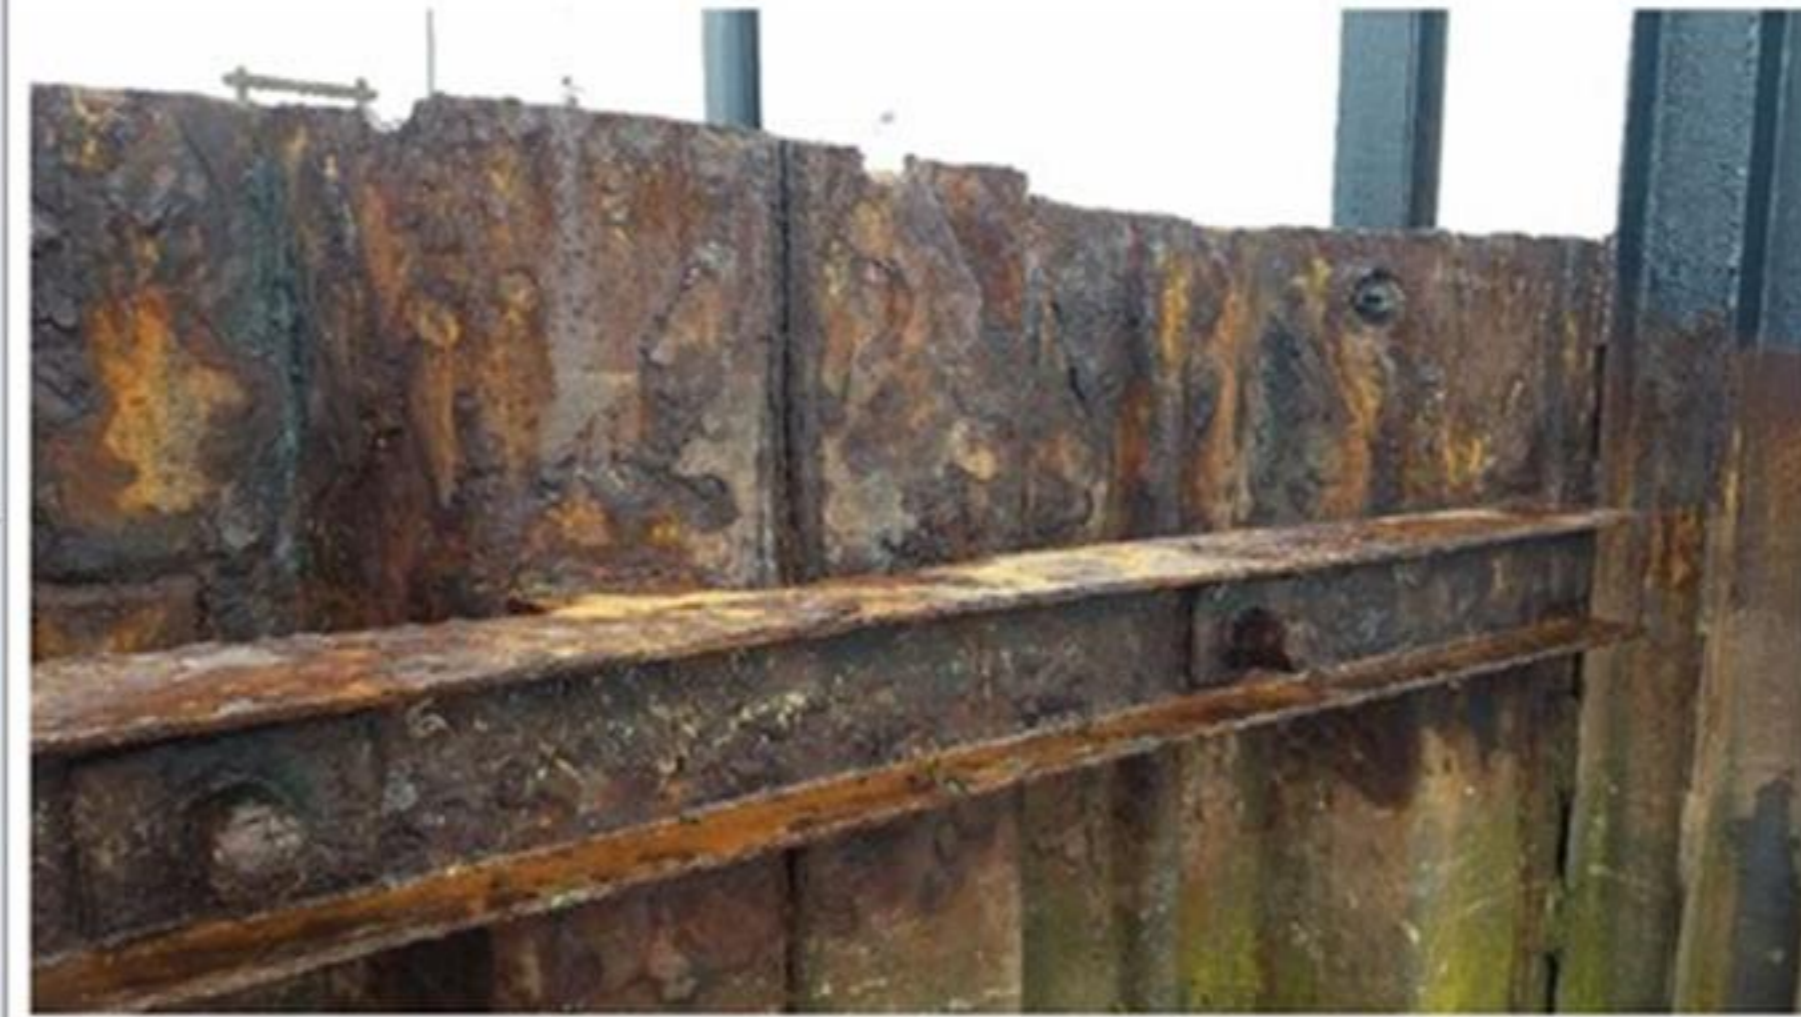
Photograph No. 27:

**Comments:**

Condition of steel at mooring structure noted. Moderate to major corrosion noted.

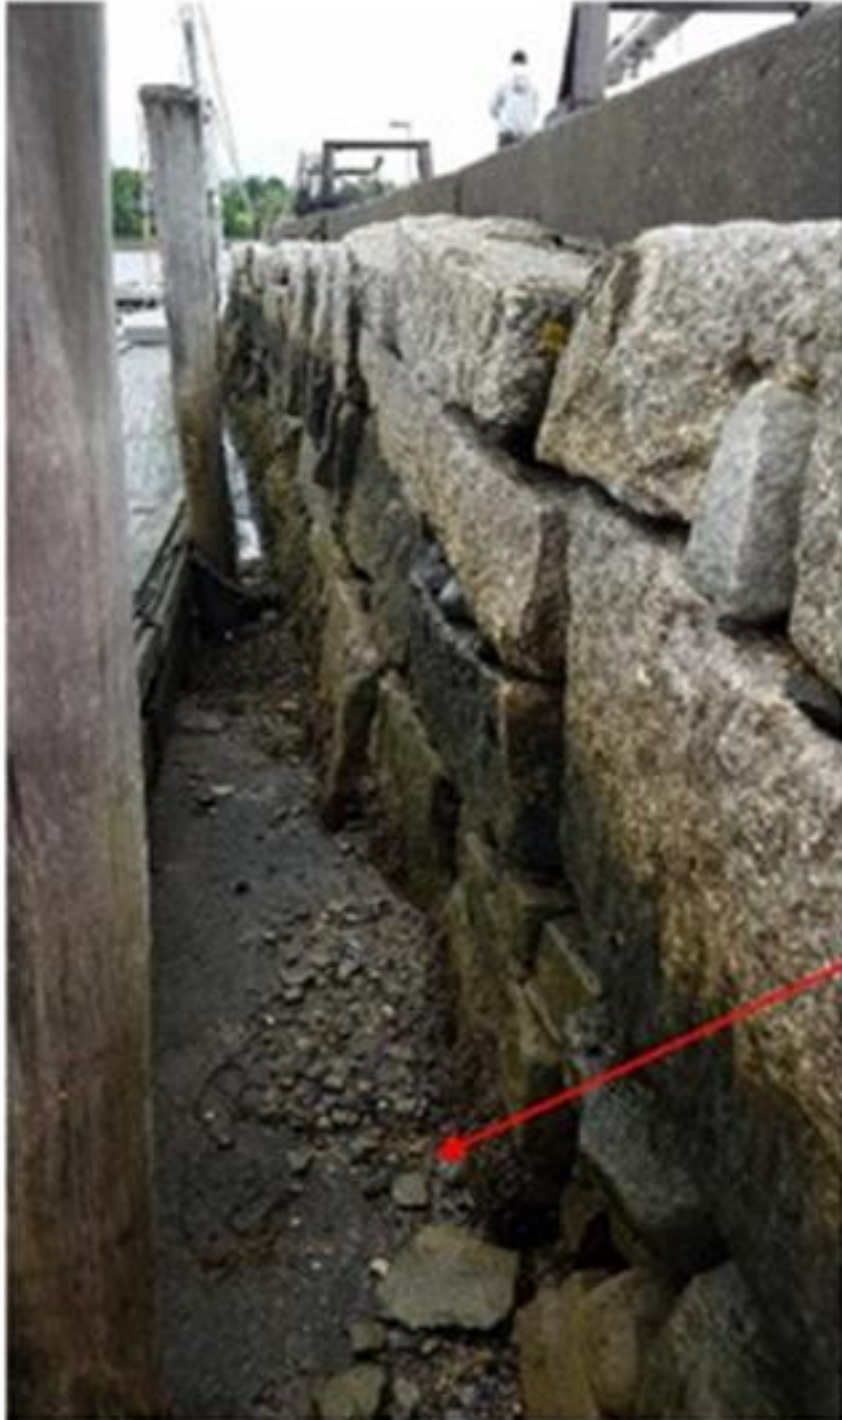
Photograph No. 41:

**Comment:**

View at north side of breakwater.

1. Material at north side which appears to have eroded from breakwater interior.

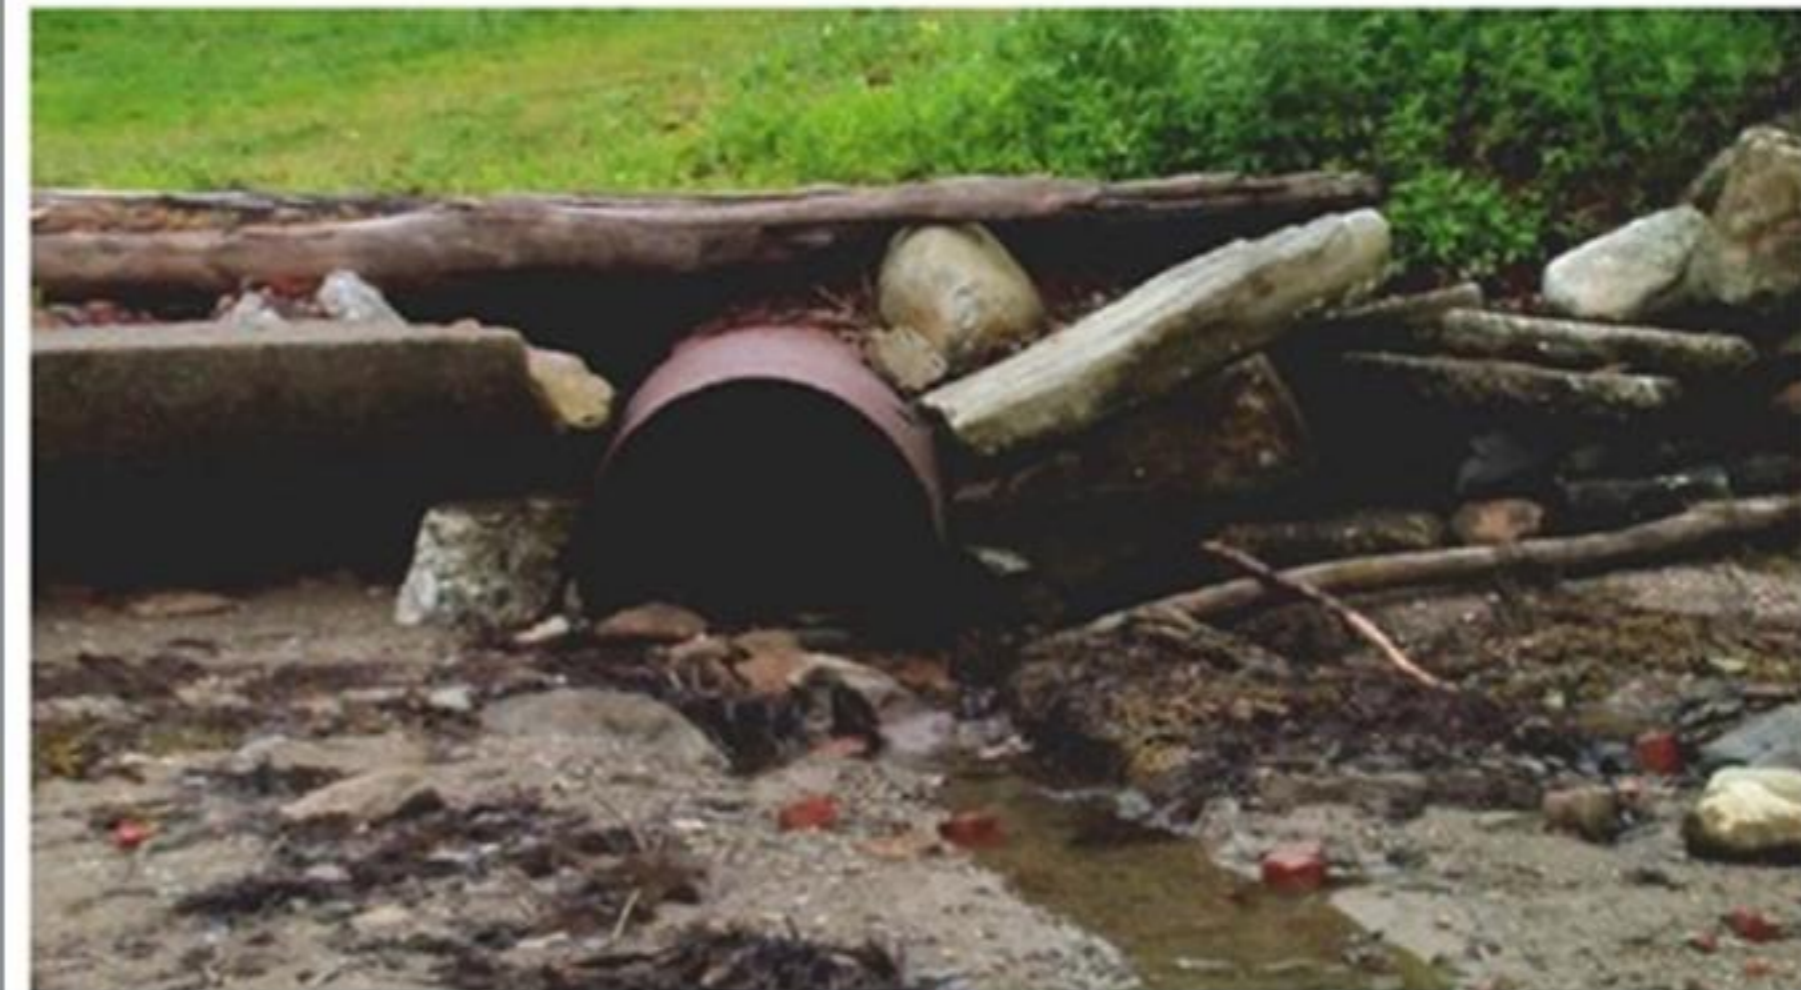
Photograph No. 38:

**Comment:**

View of drain pipe which drains into shoreline.

An unprotected channel is noted with signs of erosion.
