CASE STUDIES AND LESSONS LEARNED: THIN-LAYER DEPOSITION

Sam Whitin – EA Engineering, Science, & Technology, Inc. PBC

Beneficial Reuse and Marsh Elevation Enhancement on Rhode Island's South Shore

Migrating Shorelines: Opportunities for Coastal Adaptation

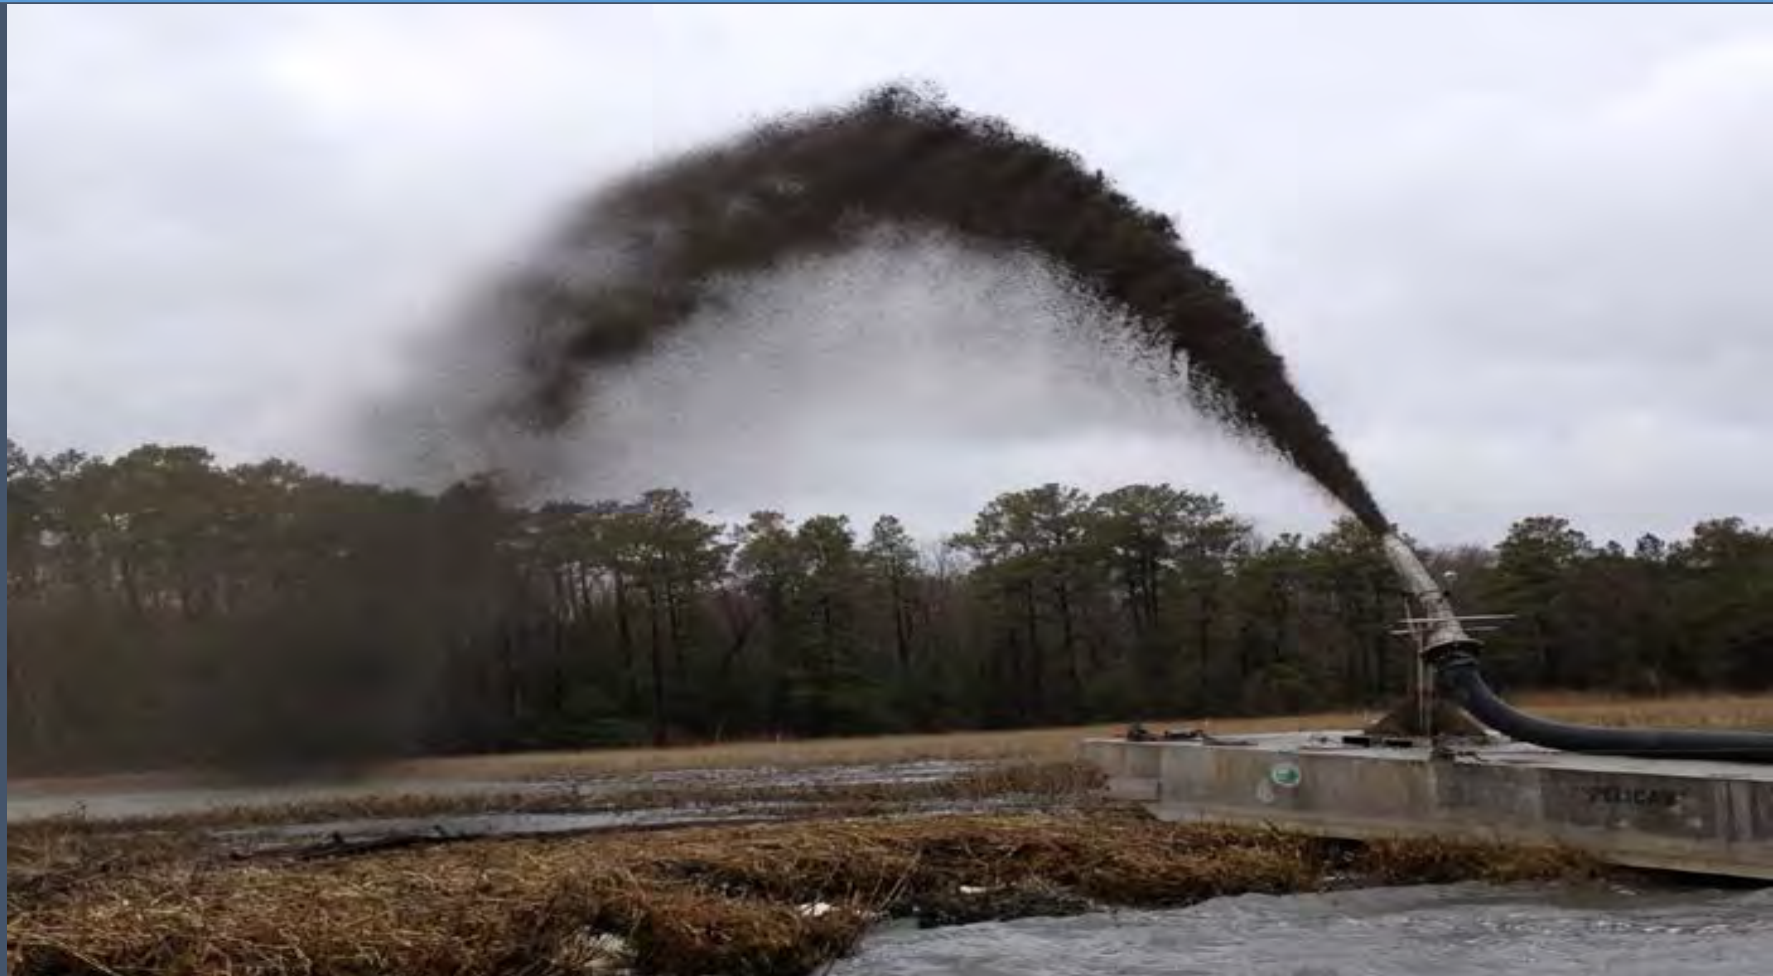
PEPPER CREEK (continued) DAGSBORO, DE

- Sediment placed was 85-90% water
- Installed hay bales/coir logs in ditches
- As a result of spray impacts, replanting of disturbed vegetation was necessary

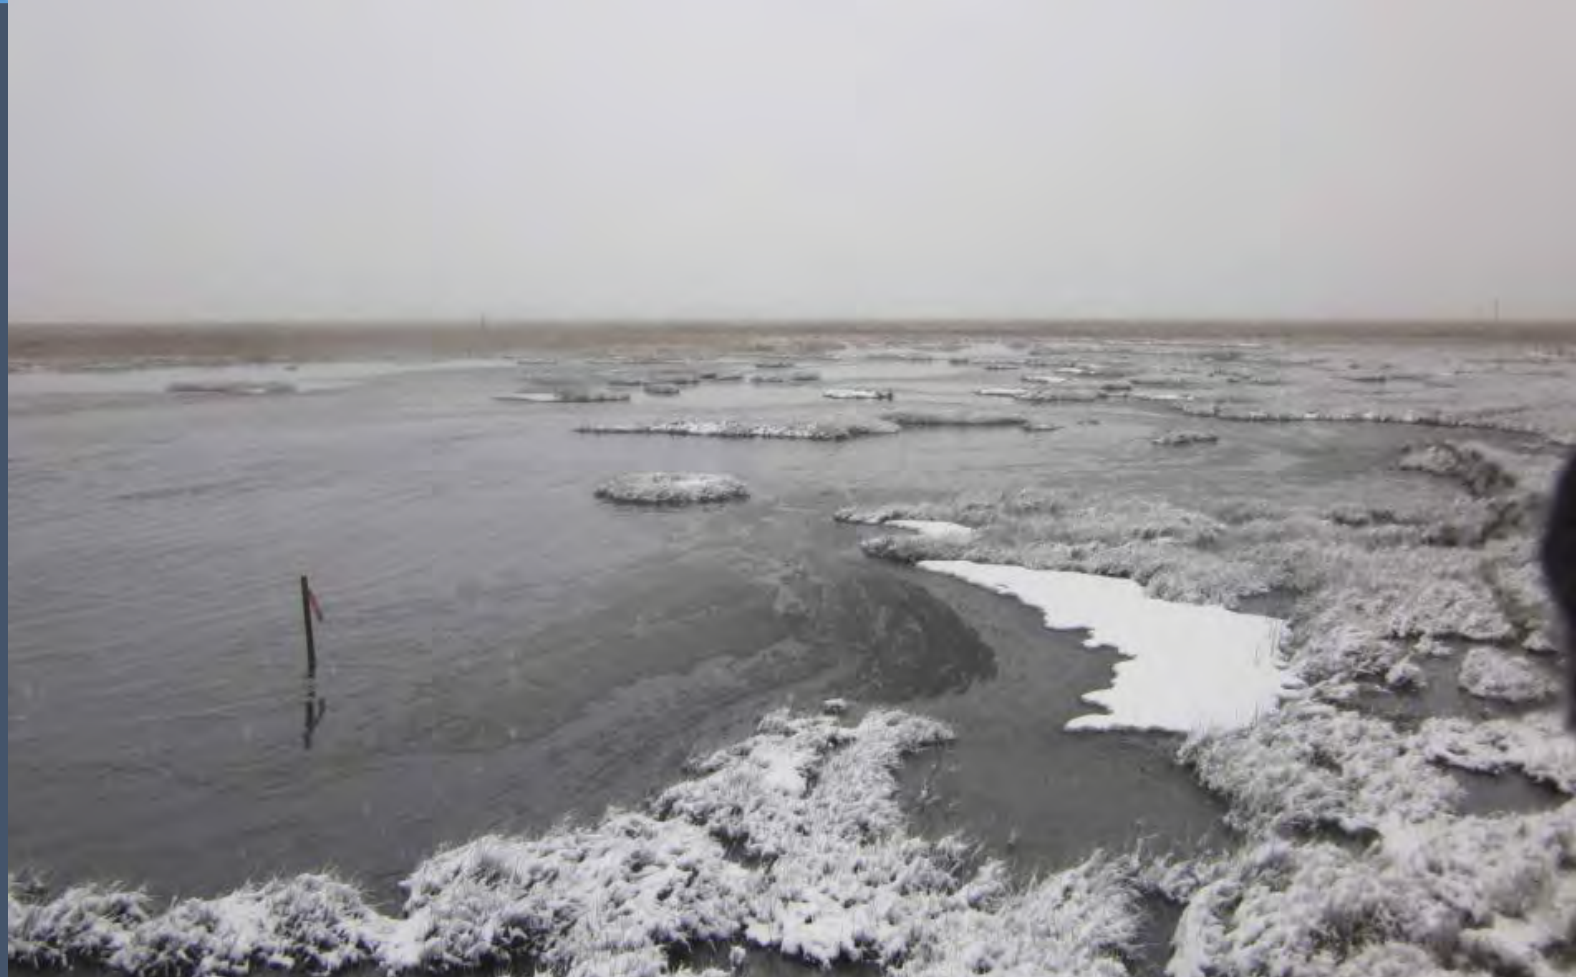
AVALON (~ \$1,500,000) AVALON, NJ

- Developed biological target elevation
- Thickness ranged from 0.5 to 20 inches in pools
- Dredge material was 16% clay, 50% silt, and 34% fine sand
- Bulking, consolidation, and settlement rates made it clear that preference would be to model first, if possible

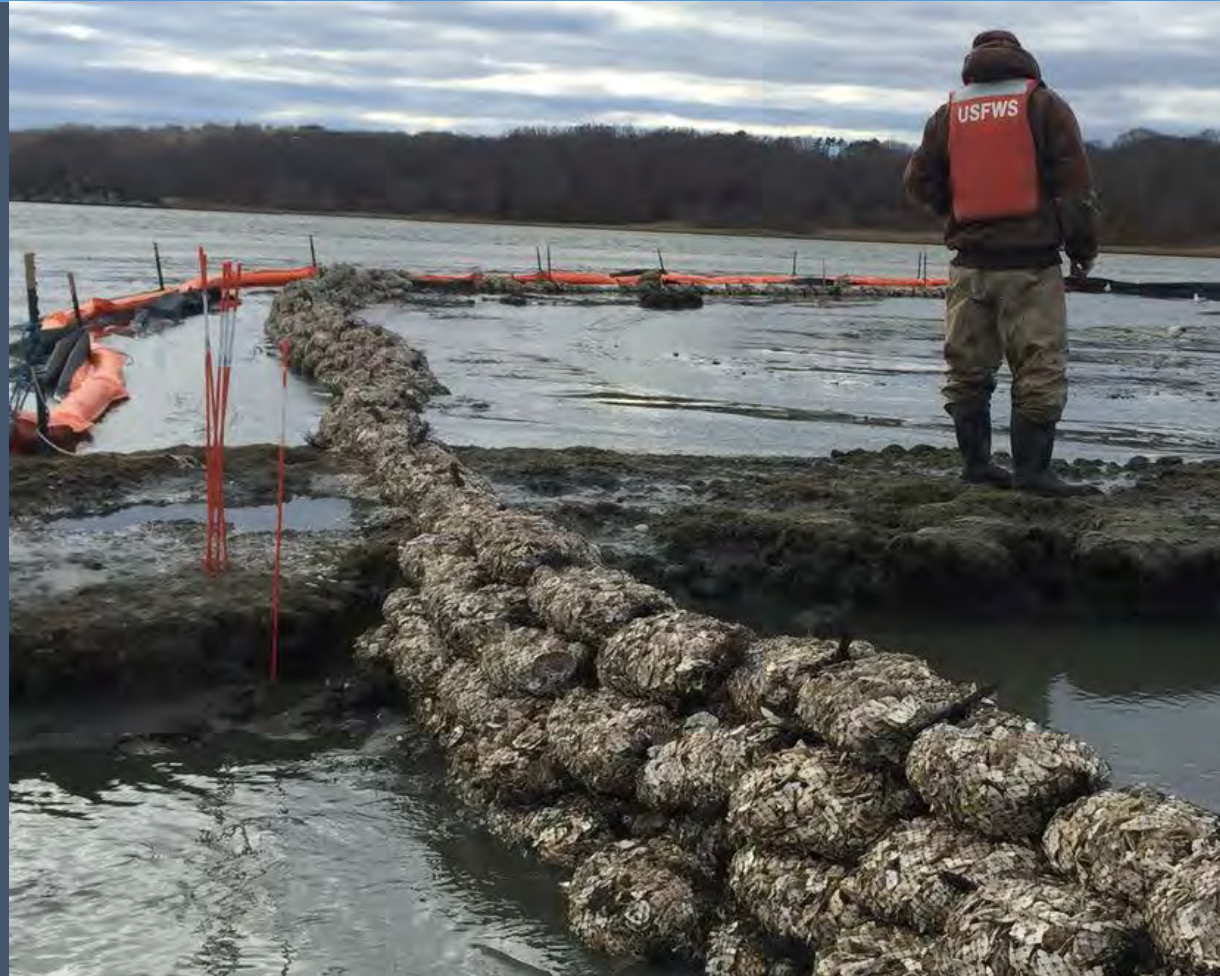
JOHN H. CHAFEE NATIONAL WILDLIFE REFUGE (continued)

- No more than 6-inch placement thickness
- Shallow water levels made dredging and equipment transportation difficult
- Custom made machinery and in-field equipment modifications
- Dredge material dispersal will be accomplished via amphibious excavator

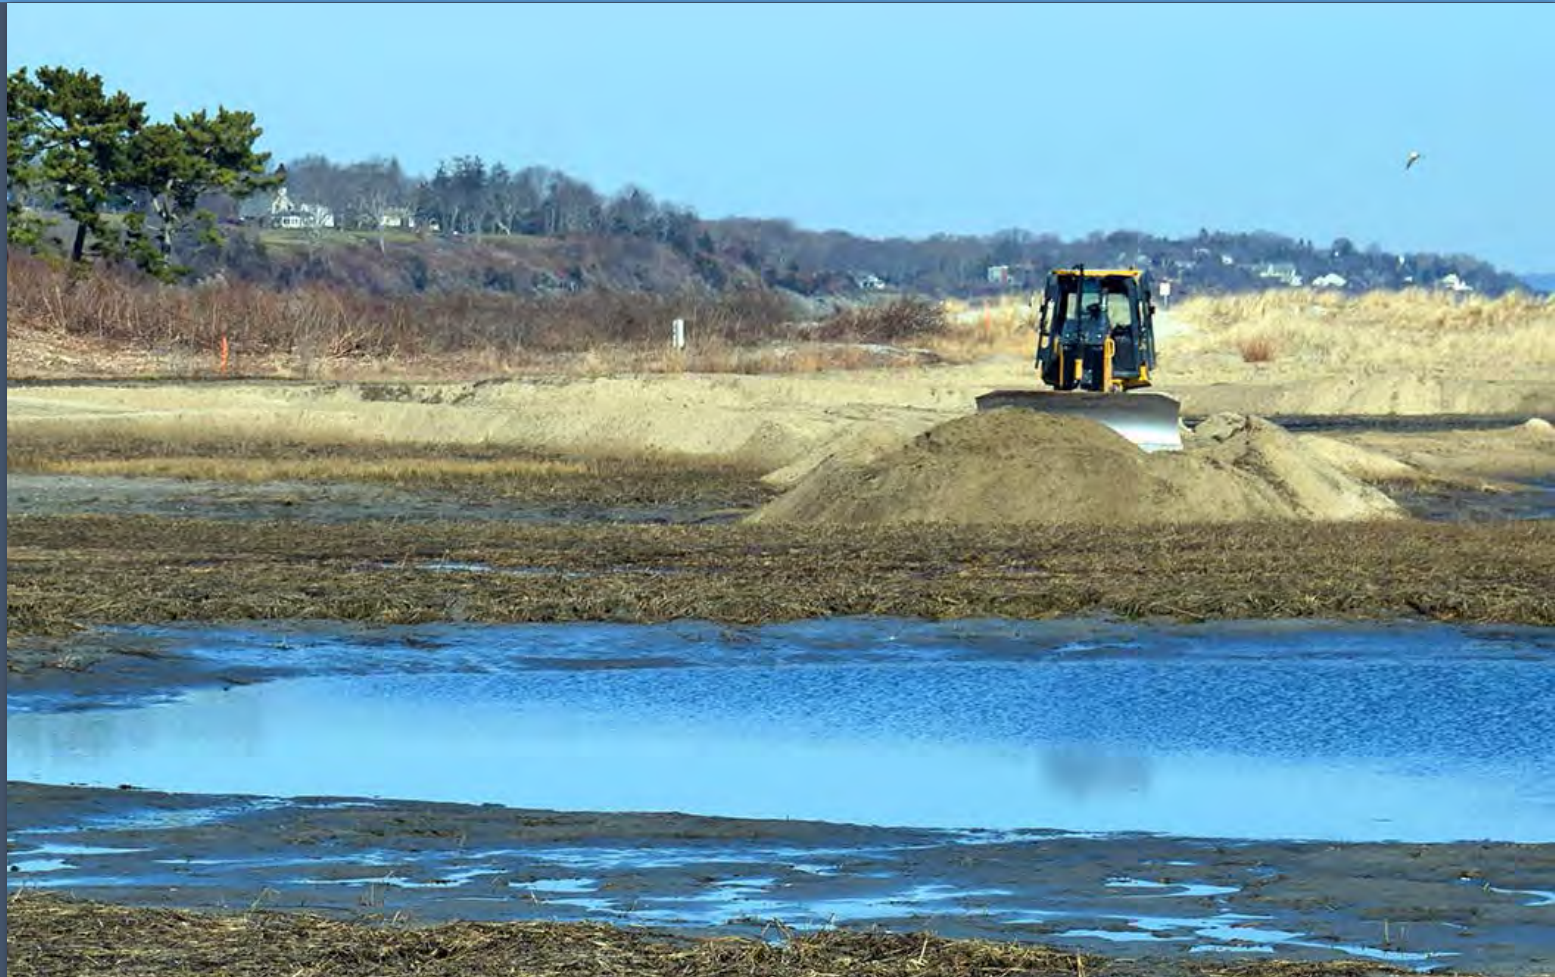
SACHUEST POINT NATIONAL WILDLIFE REFUGE (2016 ~ \$644,000)

- 11,000 CY of dredged material was applied to 11 AC
- Material was dredged hydraulically and placed on the marsh platform to dry out; placement occurred by means of spreading and grading the material with a lightweight amphibious excavator
- Encouraging results with deposition thickness from 1 to 12 inches across the marsh surface

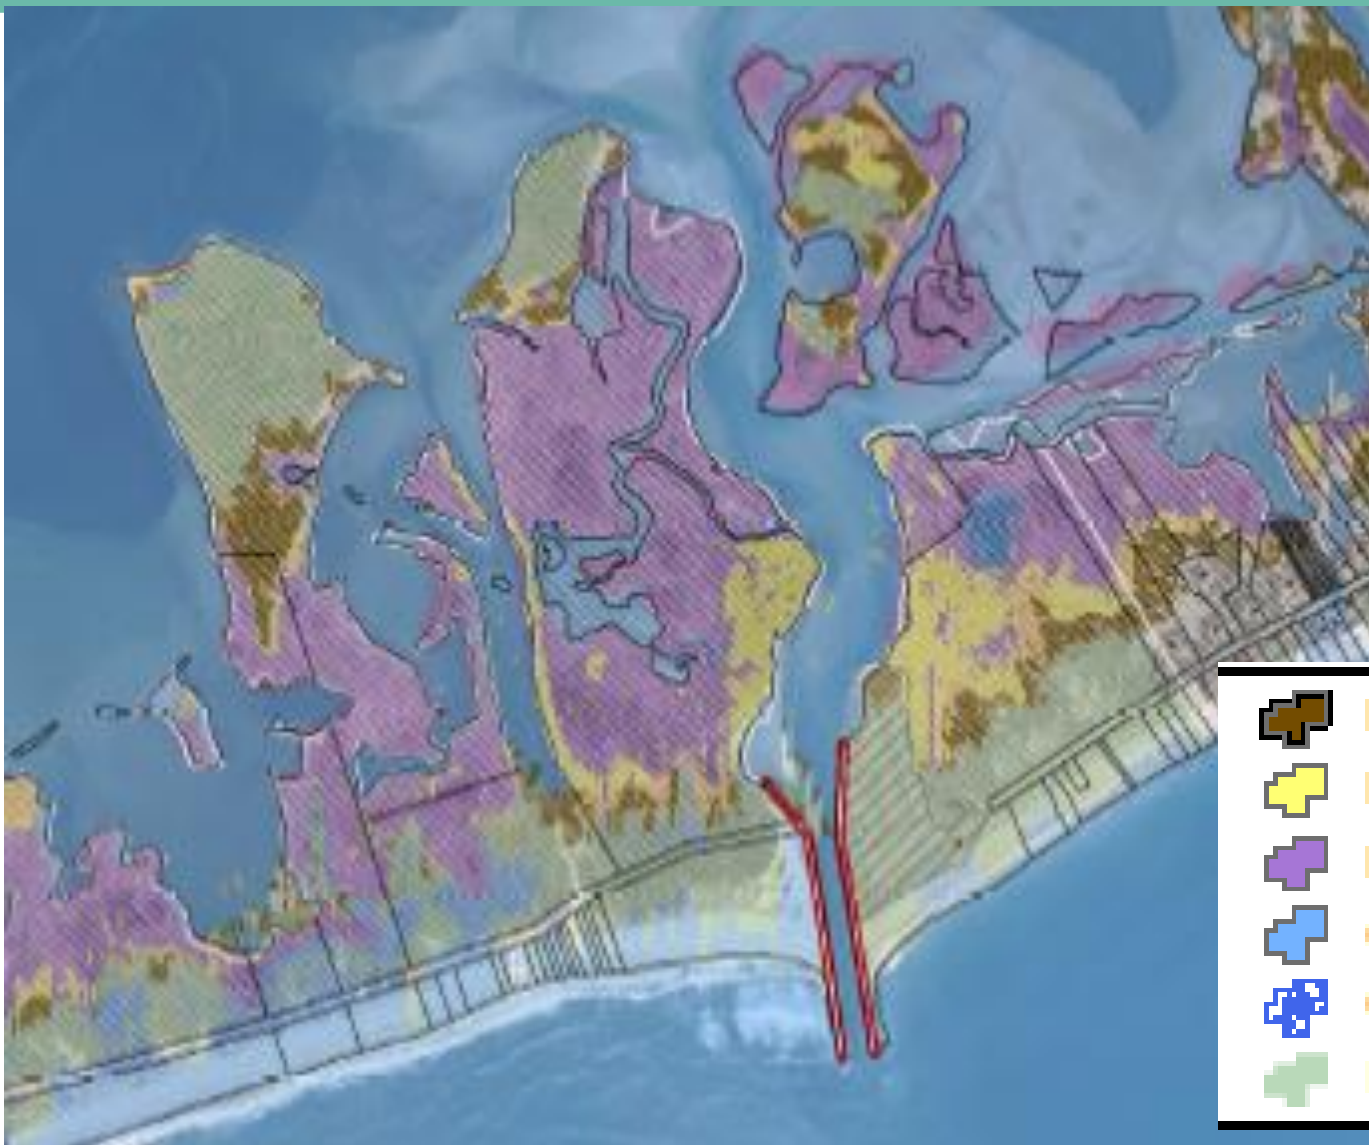
Sea Level Affecting Marshes Model Results

- Potential Marsh Zone
- Persistent Marsh Zone
- Potential Marsh Loss
- Open Water and Tidal Flat
- Current Fresh Wetlands
- Protected Open Space

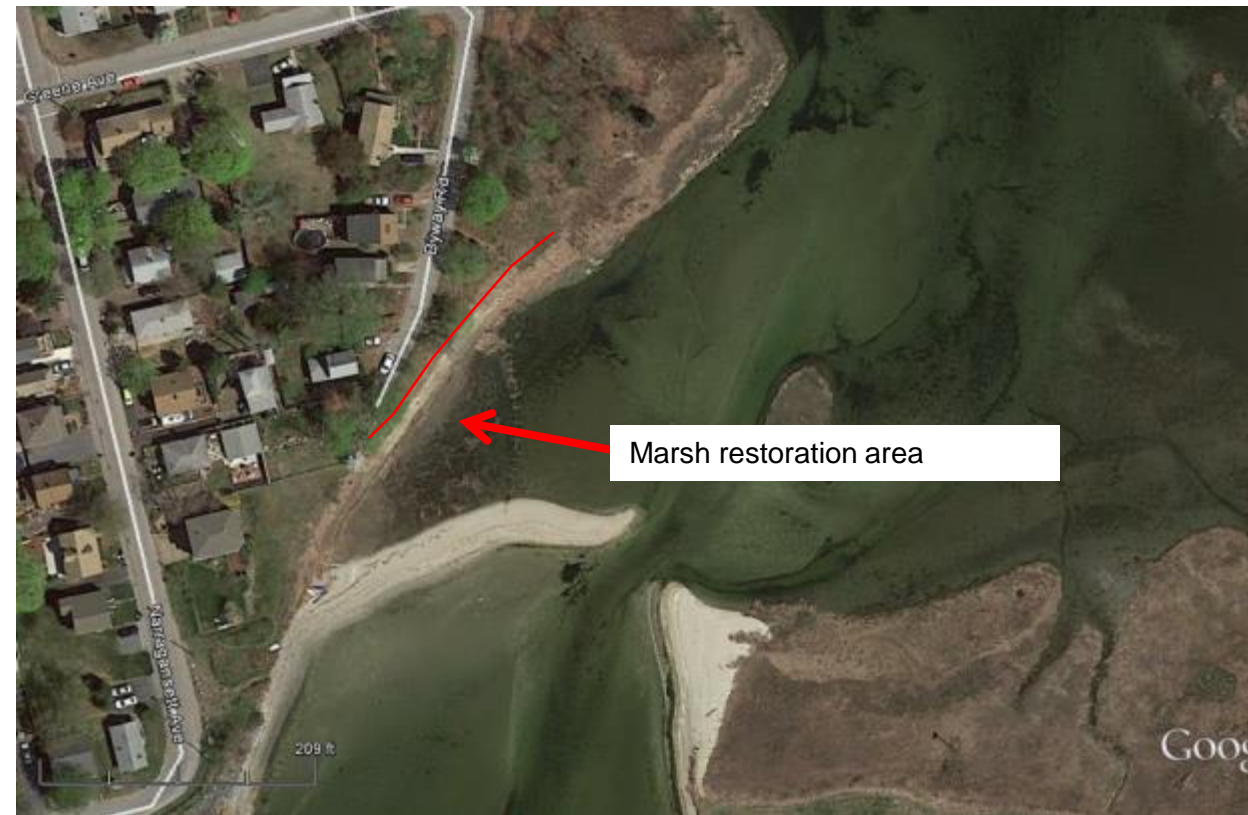
Allins Cove, Barrington: bank stabilization

Bank stabilization using coir envelopes

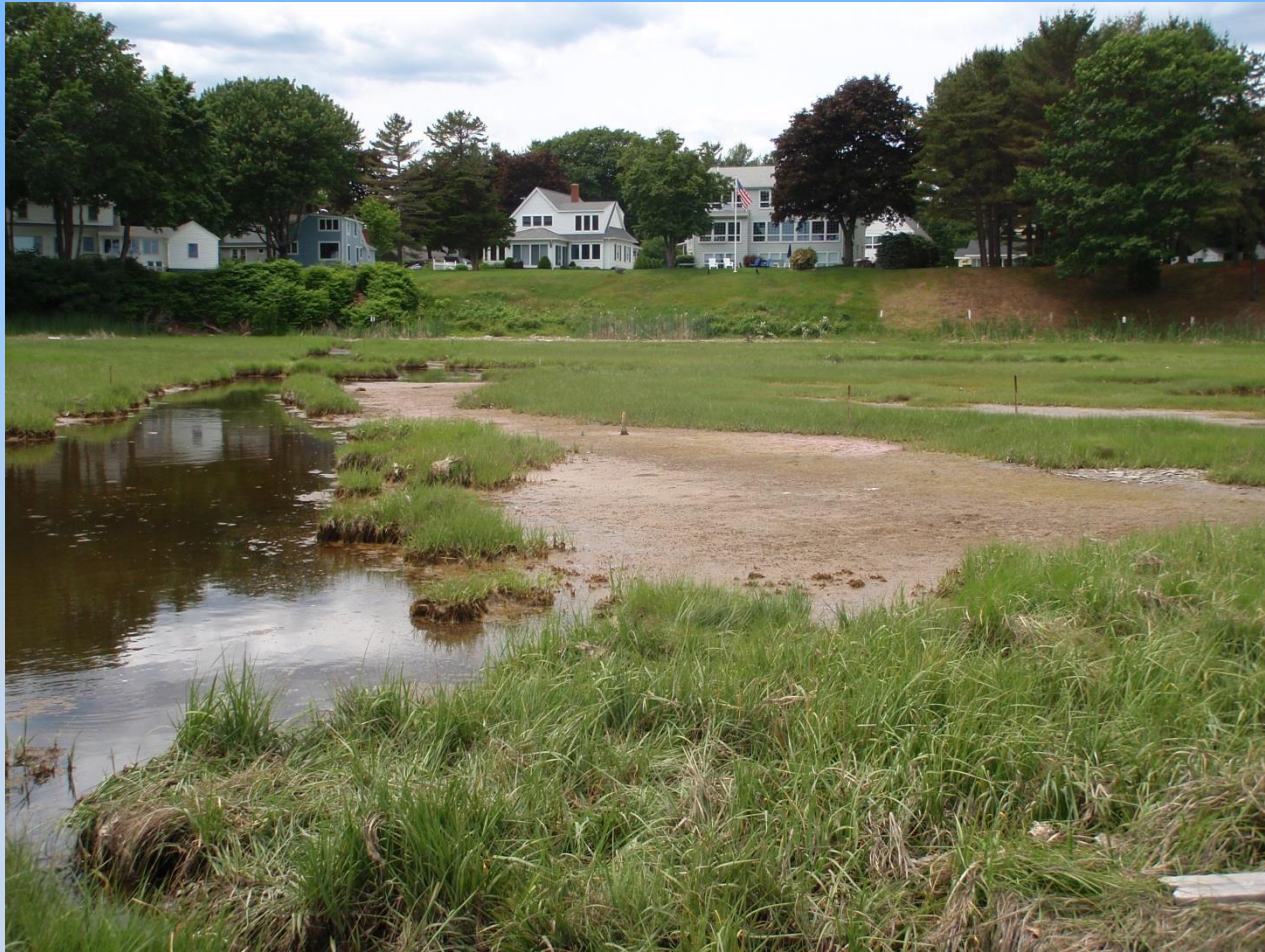
Plug removal → drawdown
