Green Infrastructure at the Local Community/Site Scale

Dan Mullins
Eastern Connecticut Conservation District

Introducing Green Infrastructure for
Coastal Resilience Conference
May 23, 2017

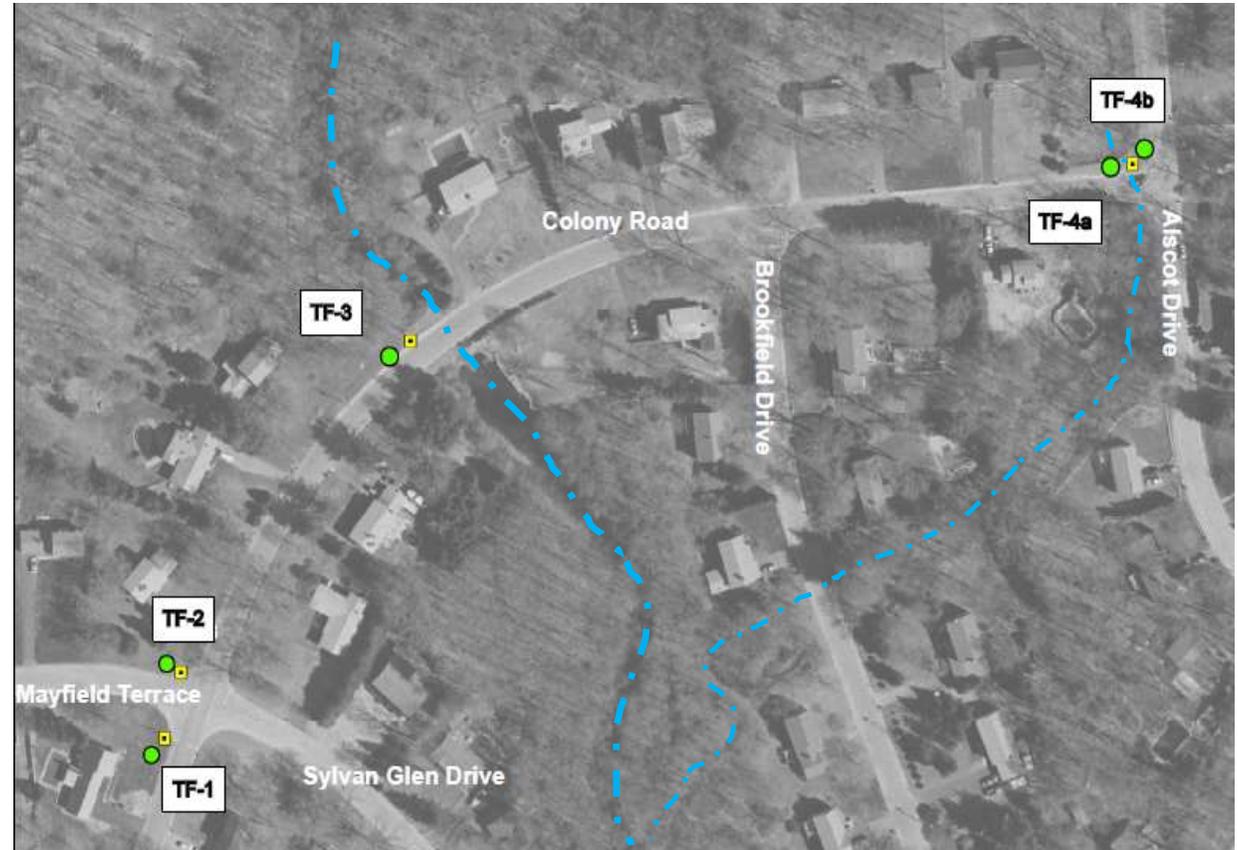
Colony Road Tree Filters (East Lyme)

Latimer Brook was listed as impaired for recreation (2010) due to fecal coliform bacteria.

In 2012, ECCD installed 5 tree filters throughout the neighborhood.

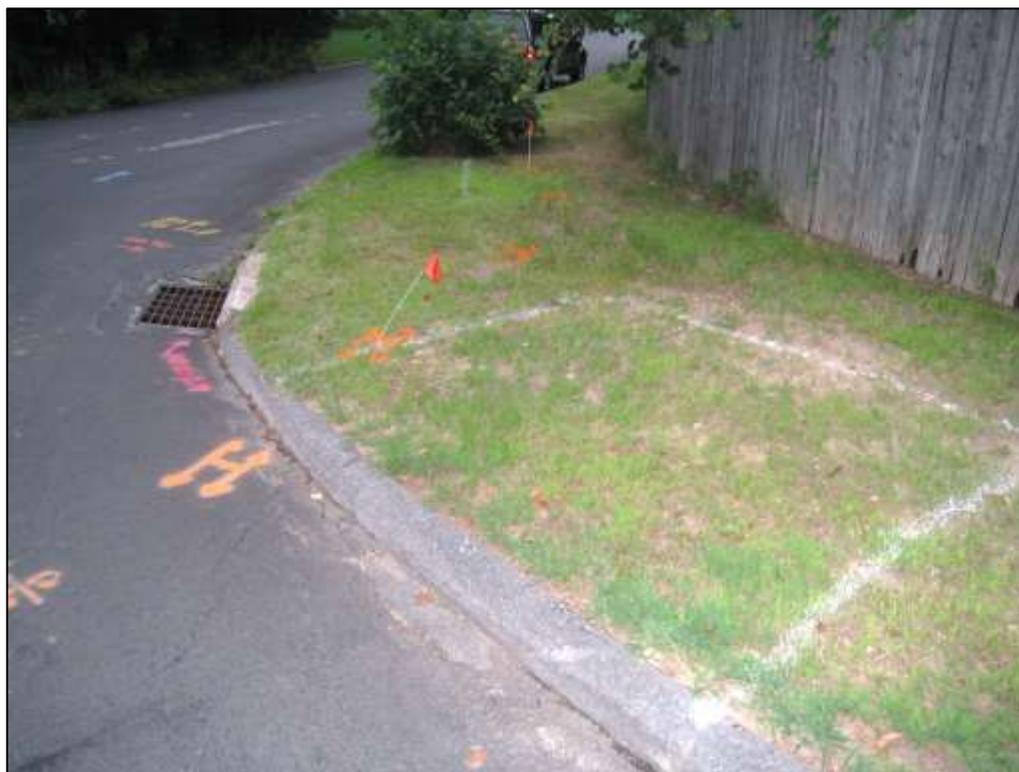
Overhead lines on the same side of the road as the stormdrain system...

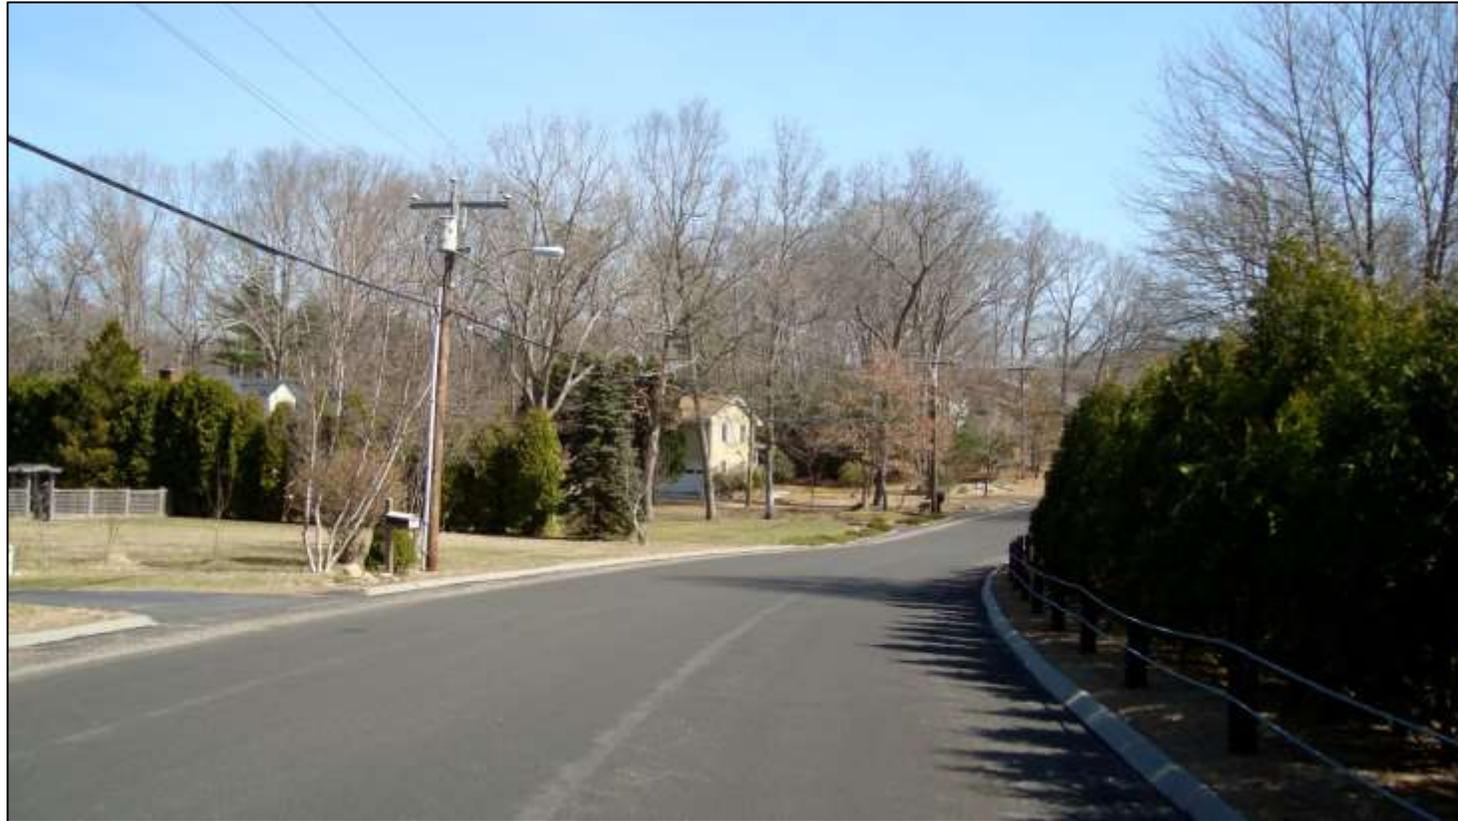
Even when you know a utility is there....

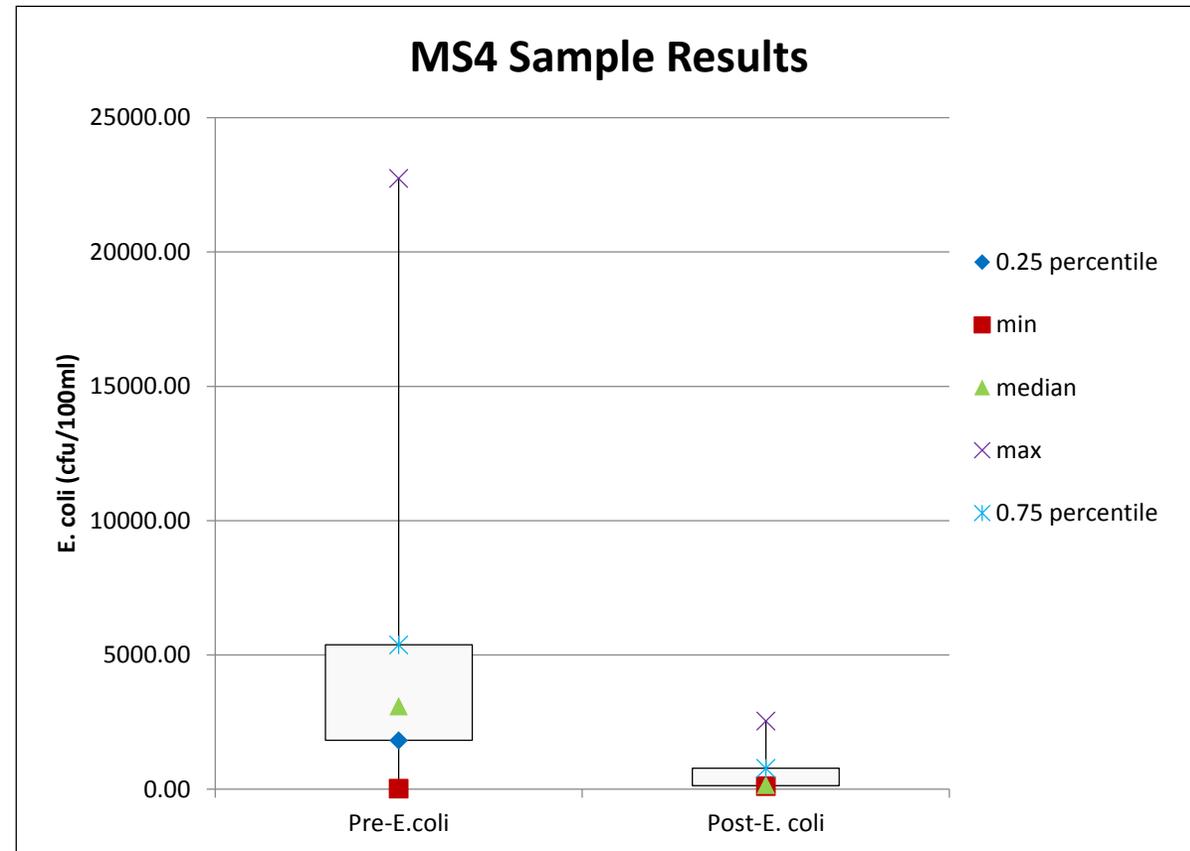
387% reduction

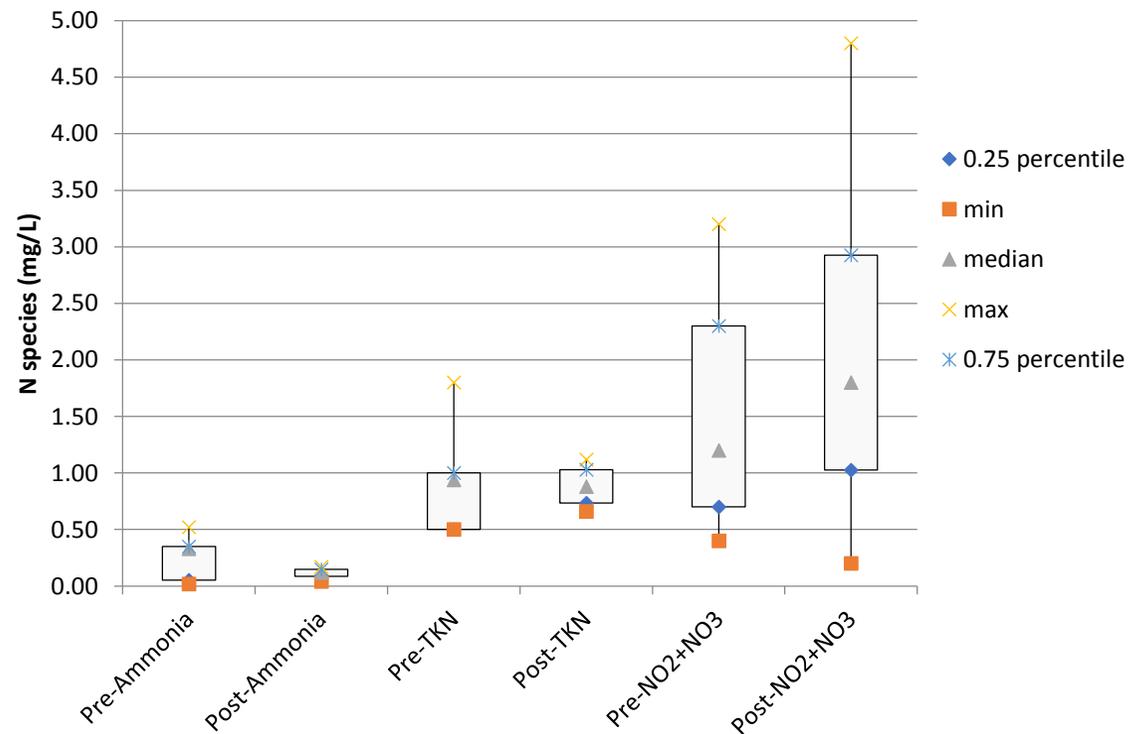
MS4 Sample Results

170% reduction 32% reduction 31% increase

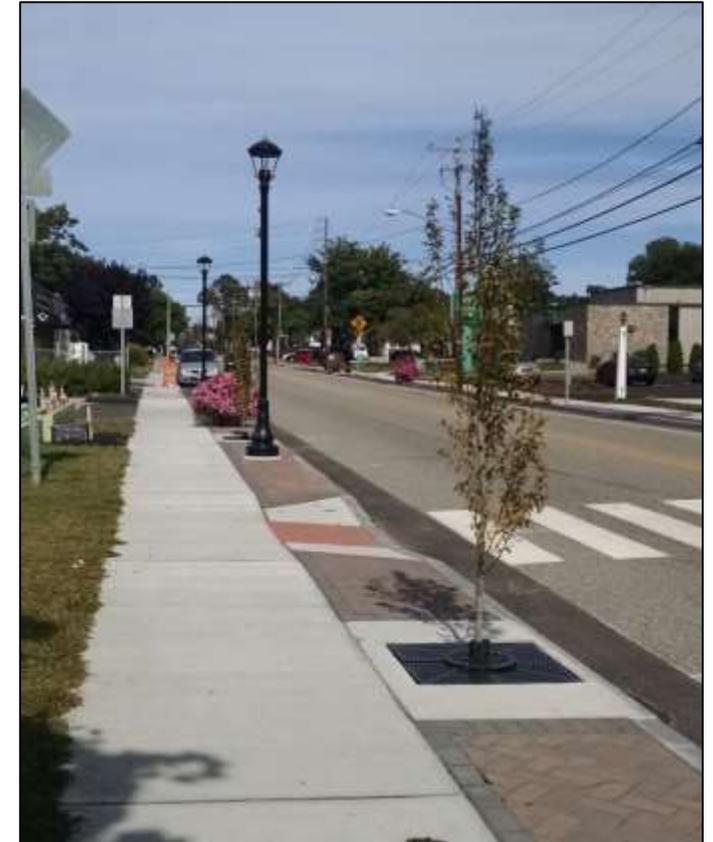
Looking north along RT 161,
by tree filter #3.

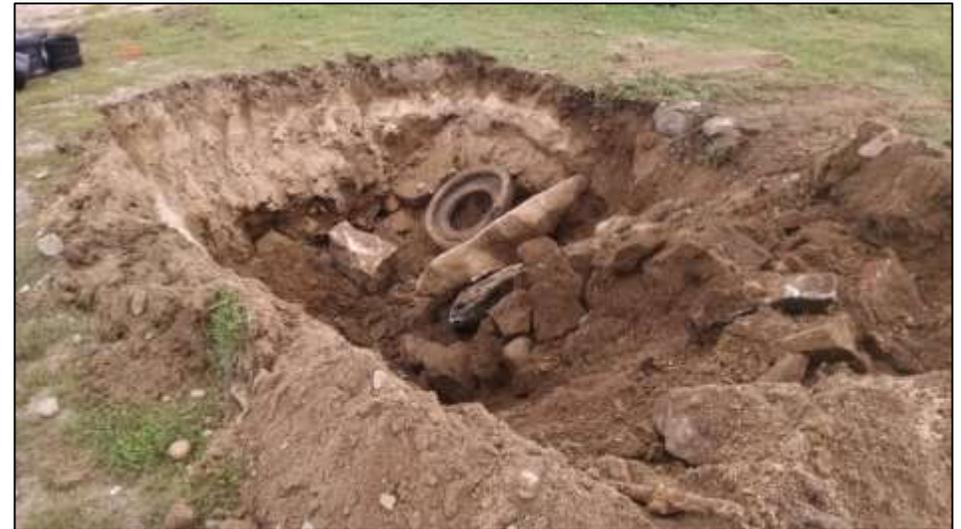
Construction debris/fill in pit for tree filter #4.

- Complex deed restrictions/permitting process
- Re-developed site (former commercial site)
- Tree filters installed ahead of storm drain infrastructure (backwards)
- Very high, tidally-influenced groundwater
- Tides back into storm drain system daily
- Flood zone considerations
- Town seeking funding to complete parking lot

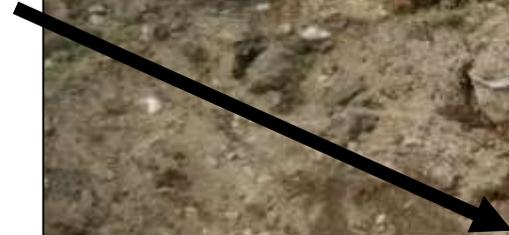
Underground storage tank

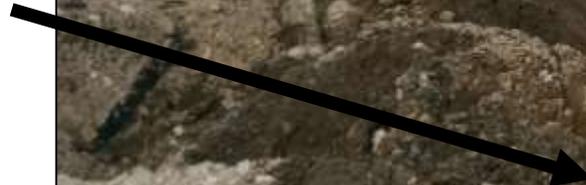
Abandoned sewer lateral

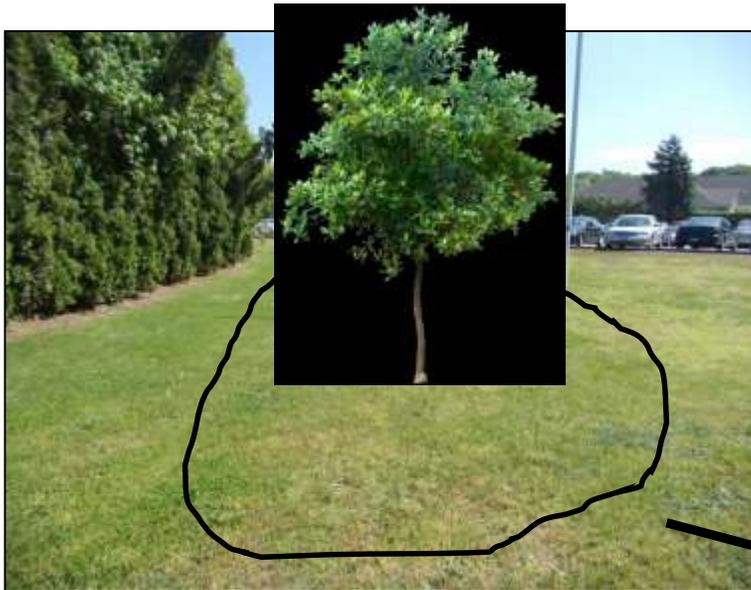
East Lyme High School – Summer 2017

Bio-retention Basin

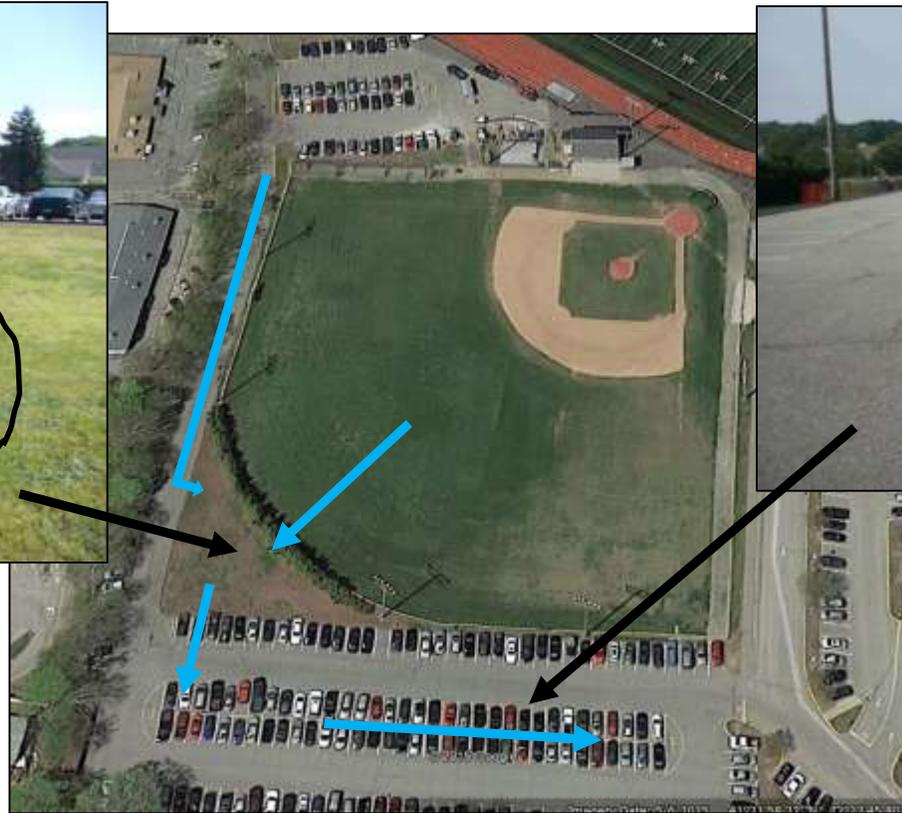
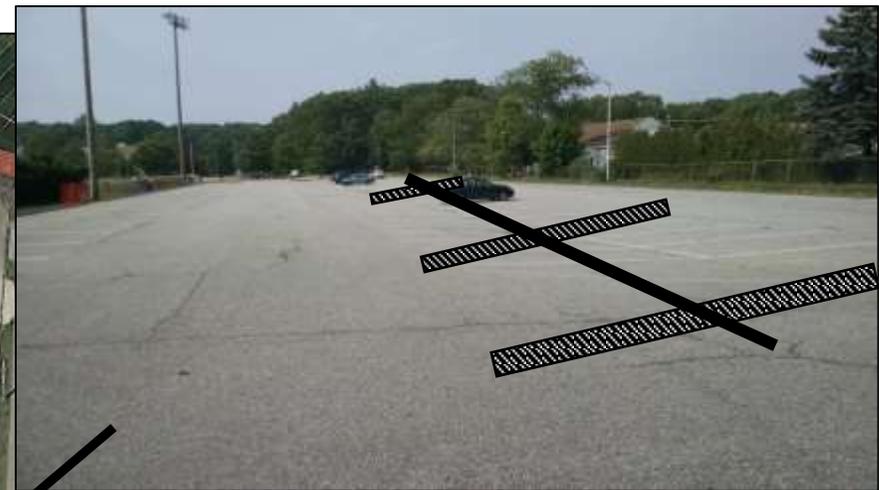
Sub-surface
Infiltration Galleries
