Coastal Bank – Engineered Core

Coastal bank protection, including slope grading, terracing, and toe protection and vegetation planting will reduce the steepness and protect the toe of the bank from further erosion. Engineered cores, of sand filled tubes, provide added protection from future bank erosion.

Design Schematics

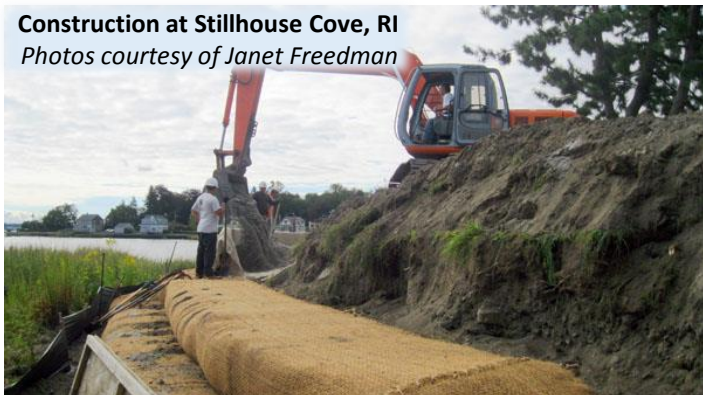
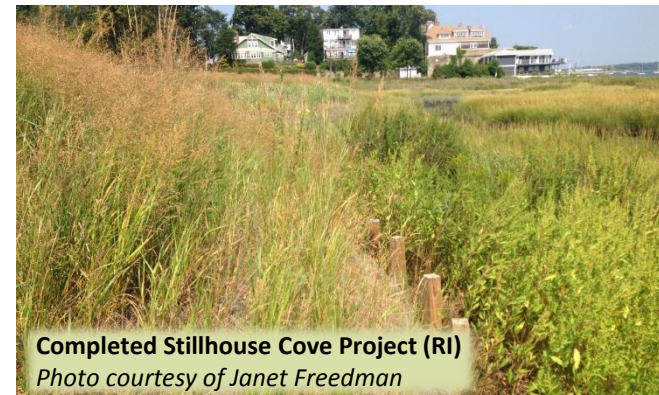
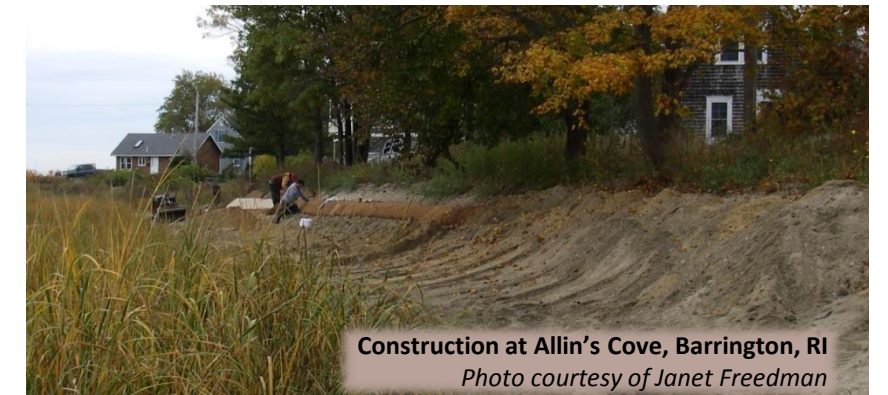
Stillhouse Cove, Cranston, RI

Stillhouse Cove is the site of a public park and a previous salt marsh restoration project that was completed in 2007. Restoration of the coastal bank was initiated after Superstorm Sandy caused extensive erosion which over-steepened the bank and washed fill and soil into the adjacent marsh. Save The Bay and EWPA, working closely with the USDA Natural Resources Conservation Service, developed a design to reinforce and protect the eroding bank by reconfiguring the slope and using natural materials and vegetation.

Project Proponent	City of Cranston, RI, Edgewood Waterfront Preservation Association (EWPA), Save The Bay, Natural Resources Conservation Service (NRCS).
Status	Completed in 2013. Maintained in 2014 (added coir logs and plantings).
Permitting Insights	The project had several iterations but was finally permitted as a Sandy Emergency Assent. An extension was required due to challenges of securing funding within the permit time frame.
Construction Notes	A key component of this project was regrading the bank from a vertical cut to create a more gradual slope. Once the slope was regraded, sand filled coir envelopes were installed, covered with soil and planted with salt tolerant vegetation.
Maintenance Issues	3 coir logs were installed at the southern end of project and planted with warm season grasses as part of the Dept. of Interior Hurricane Sandy Relief Grant Program. The base of the bank will be more frequently inundated as sea levels rise.

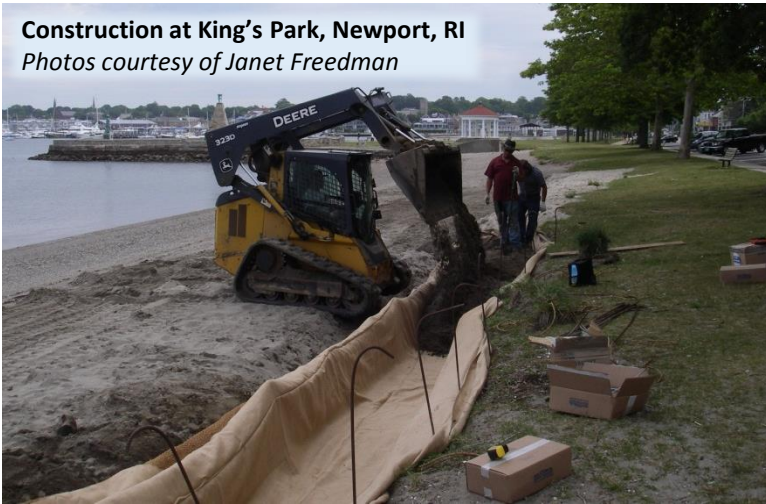
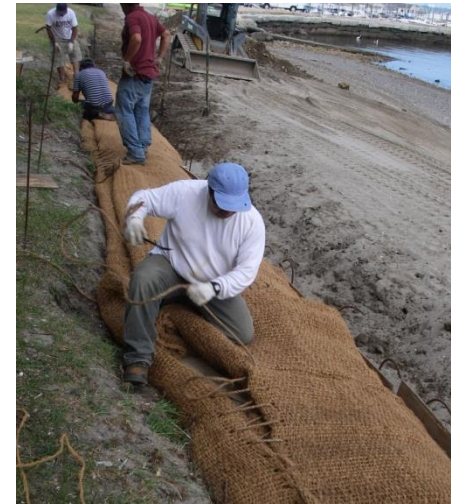
Construction at King's Park, Newport, RI
Photos courtesy of Janet Freedman
