# Coastal Bank - Natural

Coastal bank protection, including slope grading, and toe protection and planting of natural vegetation will reduce the steepness and protect the toe of the bank from further erosion. Coir logs, root wads protect bank toes from erosion, while planted vegetation develops strong root systems.

### Coastal Bank Stabilization, Orleans, MA

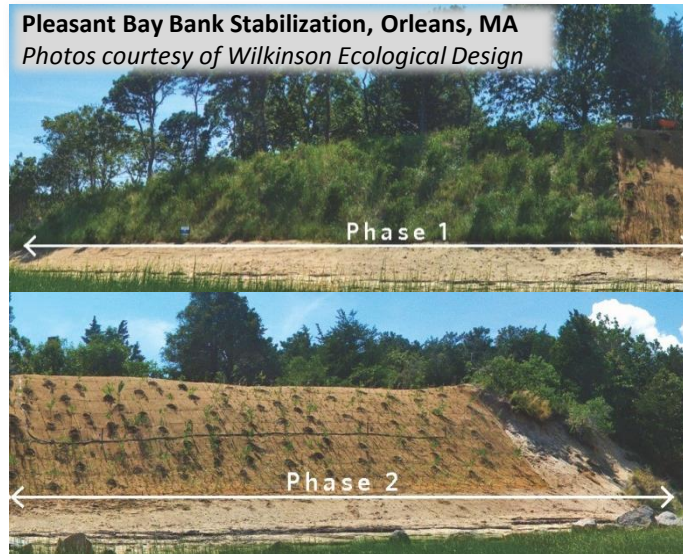
**Pleasant Bay Bank Stabilization, Orleans, MA**  
Photos courtesy of Wilkinson Ecological Design

Wilkinson Ecological Design developed a plant-focused coastal bioengineering project, determined not to be a coastal engineering structure by the local municipality and MA DEP. The project included a robustly anchored fiber roll array at the bottom of the bank and intensive planting and stabilization through the remainder of their coastal bank, which falls within a mapped FEMA Velocity Zone.

<b>Project Proponent</b>	Private property owners. The project spans three properties with multiple owners.
<b>Status</b>	Phase 1 constructed in 2010, Phase 2 constructed in 2013 and Phase 3 constructed in 2015.
<b>Permitting Insights</b>	The project involved one permit under the MA Wetlands Protection Act for each phase, three wetland permits in total.
<b>Construction Notes</b>	Regraded the over steepened bank, installed six rows of coir rolls at the toe of bank, installed natural fiber blankets on the bank face above the coir rolls, planted the bank face with native, salt-tolerant grasses and shrubs, and covered fiber rolls with sand.
<b>Maintenance Issues</b>	Monitor vegetation monthly throughout the growing season to ensure plant success; temporary irrigation for first three years; monitor coir rolls twice annually and after storms. Replant and retighten fiber roll anchoring system as needed.
