The Latest Developments in Non-structural Alternatives for Shoreline Stabilization

The Latest Developments in Non-structural Stabilization Alternatives for Shoreline Stabilization

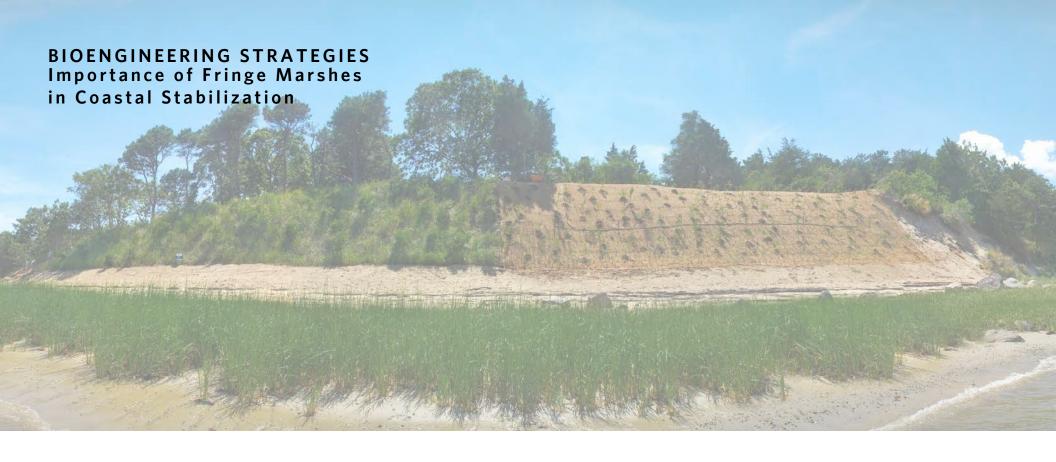
• Woven coir-filled mats used as a growing medium.

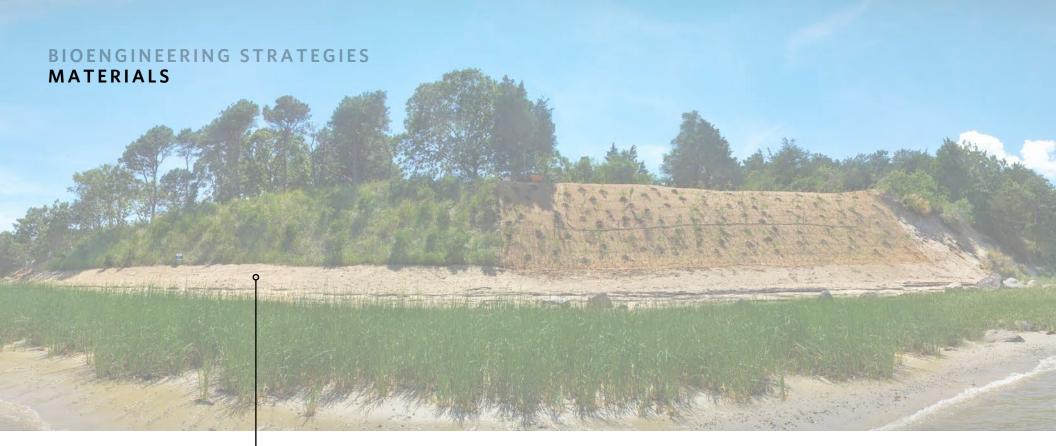
COIR FIBER ROLLS

Adds stability and protection to the toe of a bank and provides a window of opportunity to establish vegetation.

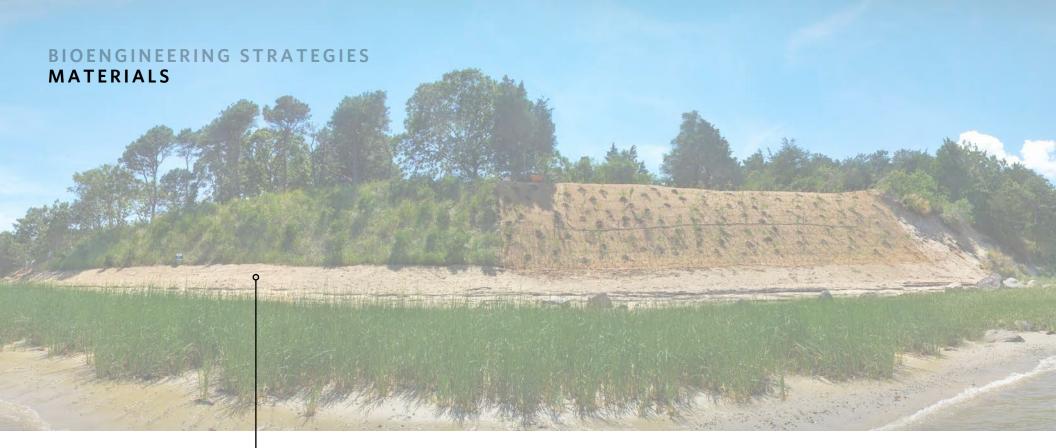
Adds stability and protection to the toe of a bank and provides a window of opportunity to establish

vegetation.

ROBUST ANCHORING SYSTEM

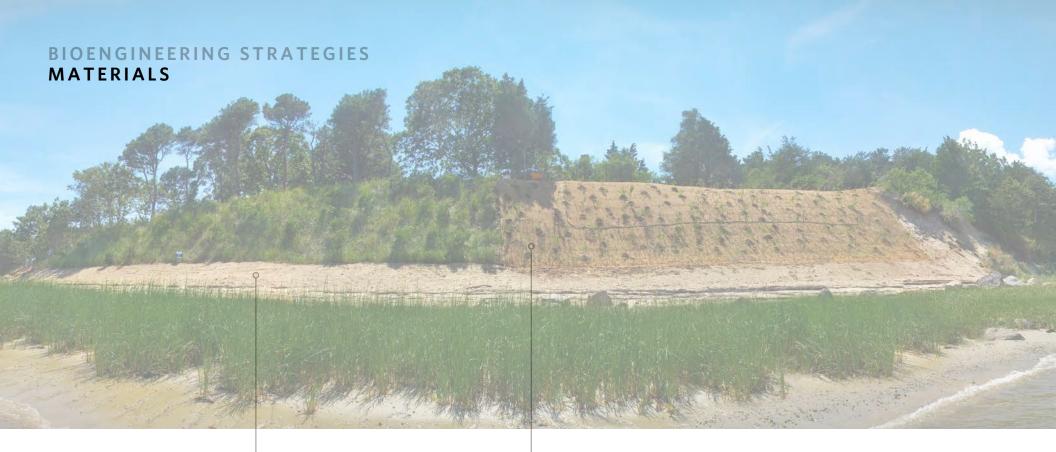
COIR FIBER ROLLS

Adds stability and protection to the toe of a bank and provides a window of opportunity to establish vegetation.

ROBUST ANCHORING SYSTEM

EROSION CONTROL BLANKETING

blanketing of natural fibers are used to stabilize soils allowing time for

- Resists degradation from the marine environment.
- Absorbs some of the force of wave energy unlike many hard solutions that deflect the energy of wave action to surrounding areas.
- Materials life-expectancy to stabilize sediments matches the time required to

**ESTABLISH NATIVE PLANTS.**

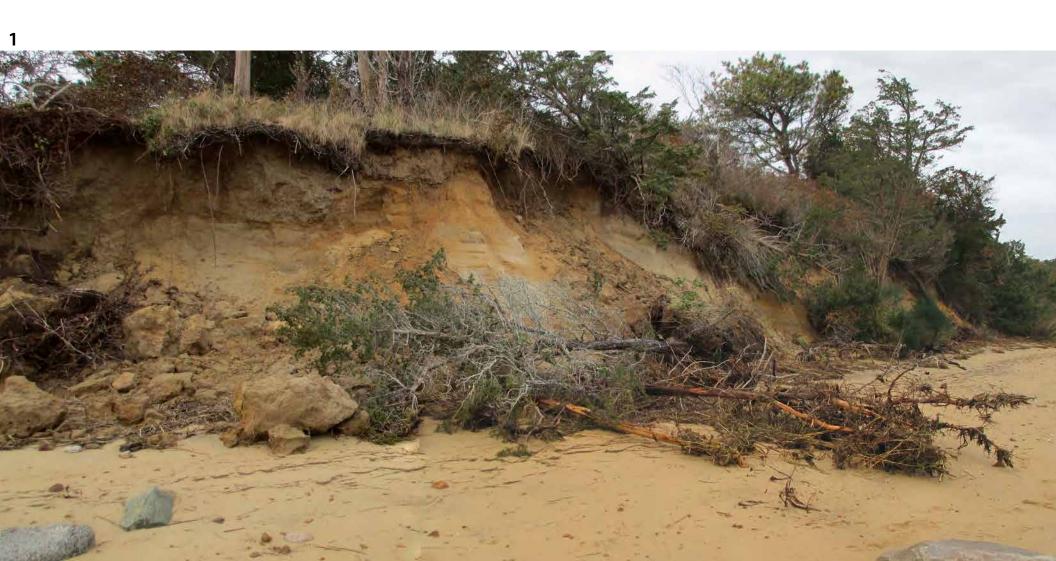
## Importance of Establishing a Stable Slope

- Utilizing a portion of the upper bank can create a more stable slope angle.
- Adds increased stability and storm damage prevention to the bank.
- Without this step, an investment in bioengeneering can be lost due to bank collapses.

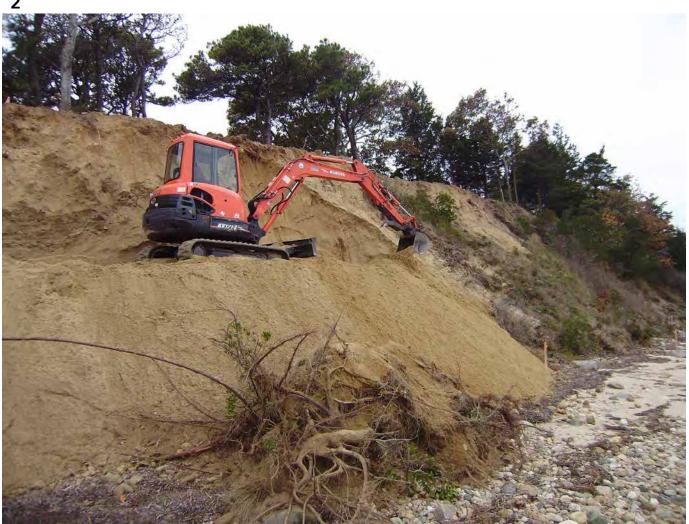
## Stabilizing toe of bank - Fiber rolls

- Installation begins at the base of the array and proceeds up bank.
- Proper anchoring strategy to hold toe protection in place.
- Synthetic filter fabrics DO NOT ENHANCE success of a bioengineering project.

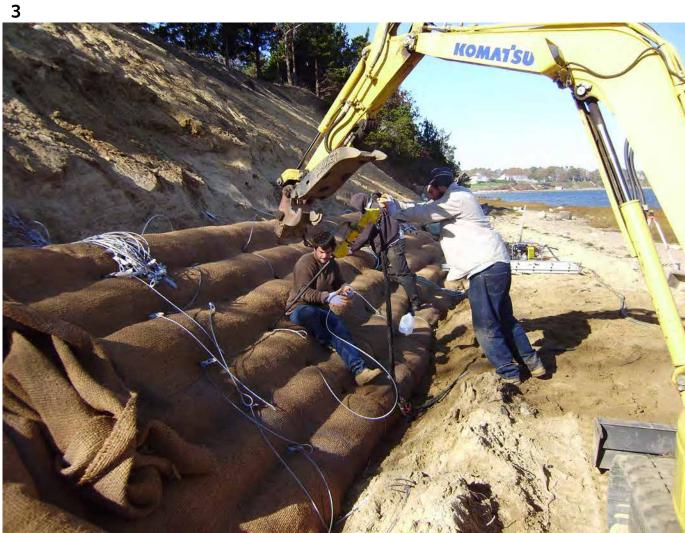
## Stabilizing toe of bank - Pre-vegetated fiber rolls

- Use of pre-vegetated fiber rolls along top of array.
- Added vegetation to the root matrix.
- Full season of plant growth prior to installation.

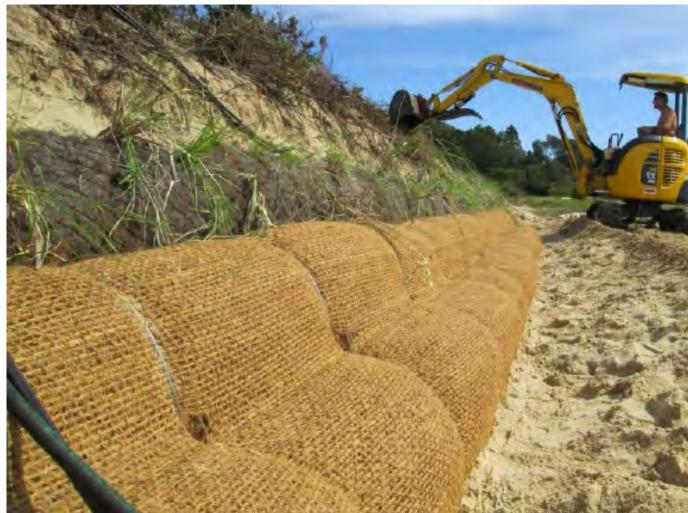
## Stabilizing soils above toe protection

- Native salt tolerant grasses are seeded into the bank prior to installation of erosion control blankets.
- Protect soils from erosion and helps to retain moisture to promote seed germination.

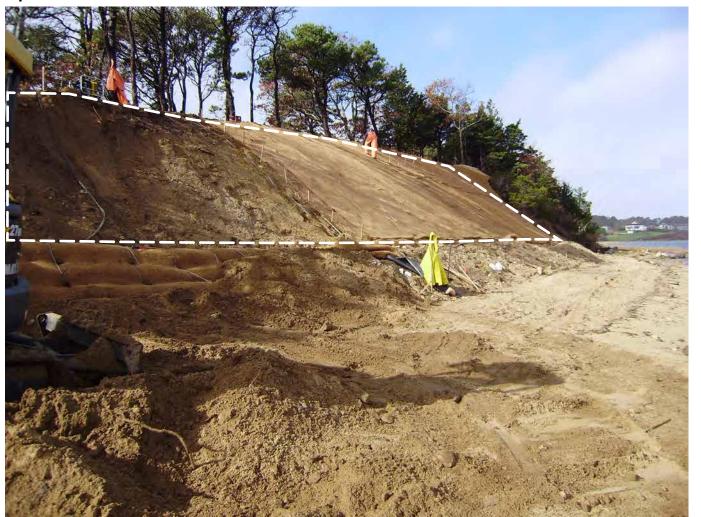
## Sand cover for fiber rolls

- Sand nourishment protects coir fiber rolls from photo-degredation "Sun Block".
- Nourishment functions as sediment source to the adjacent coastal resource areas.

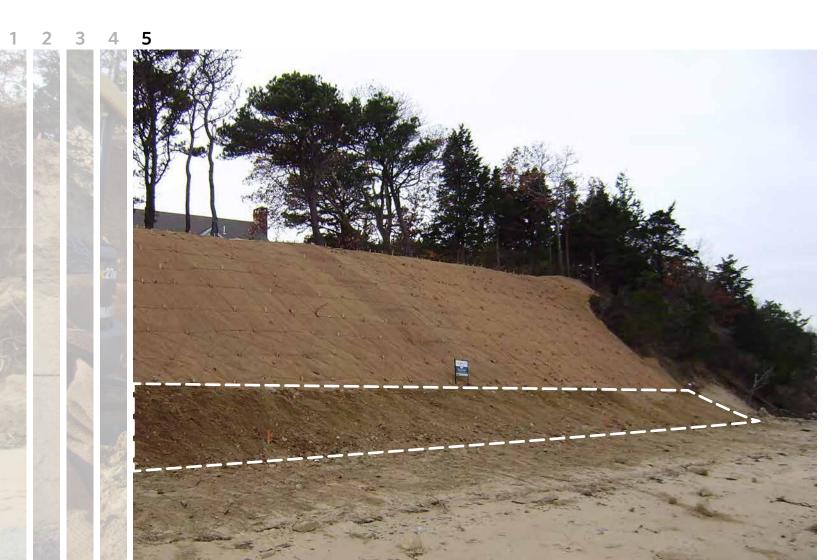
## Native shrub species

- Native beach plum and bayberry planted through erosion control blanketing.
- Temporary above ground irrigation for plant establishment.

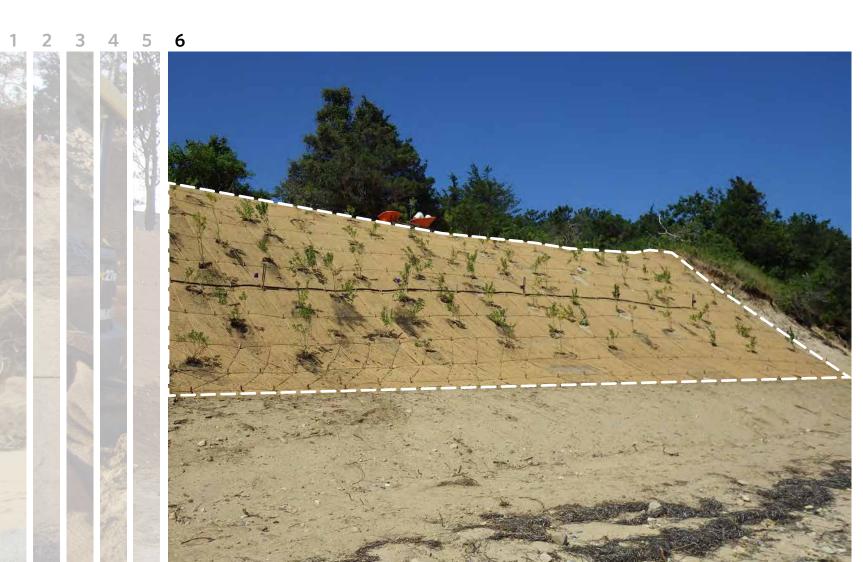
• Establishment of native vegetation after two seasons of growth.

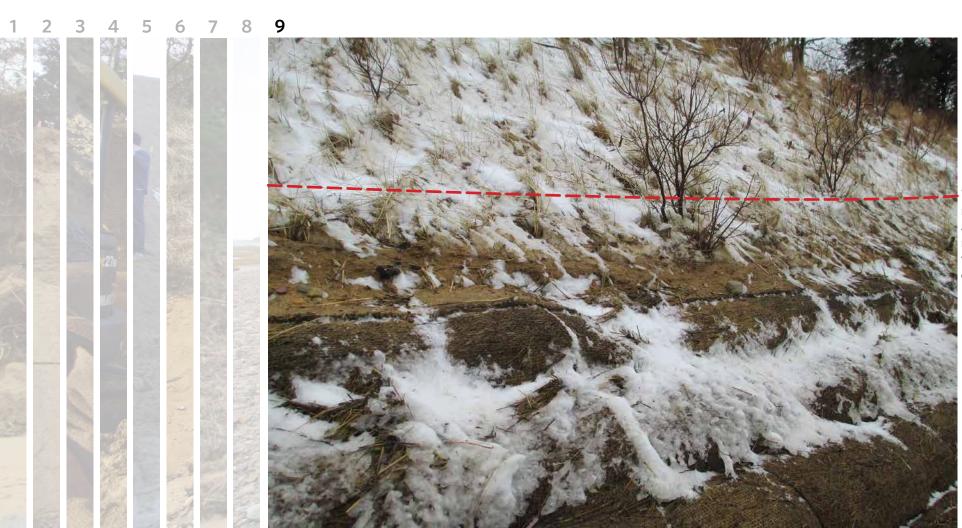
·Waves reached above fiber roll array with no damage.

Fiber roll array increased in length by 90' 6/2013
