BUILDING RESILIENCY ALONG MAINE'S BLUFF COASTLINE

Developing a Decision Tree and Coastal Stabilization Alternatives
Along Maine's Casco Bay

Presented by Troy Barry, Fluvial Geomorphologist
Introducing Green Infrastructure for Coastal Resilience May 17, 2017

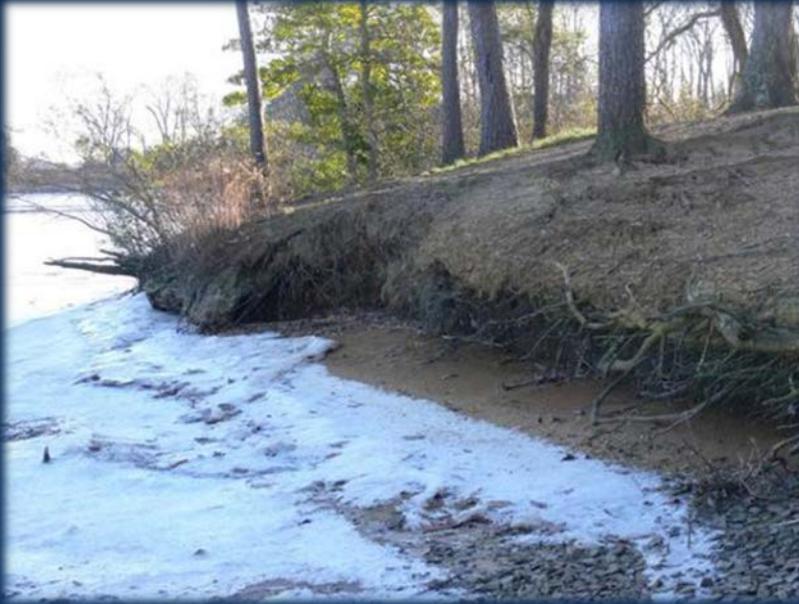
Erosion Rates and Risk

Low Erosion: 2-4 ft/y

Slight Erosion: 0-2 ft/y

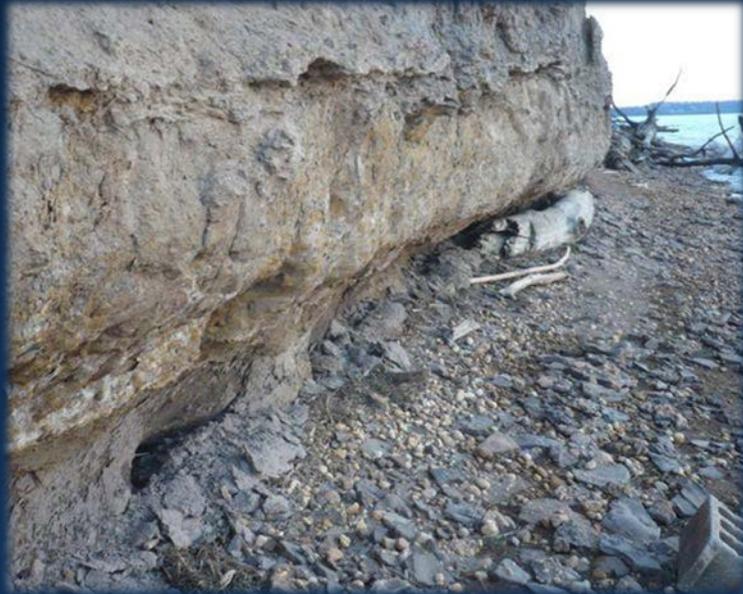
Erosion Rates and Risk

Moderate Erosion: 4-8 ft/y

High Erosion: 8+ ft/y

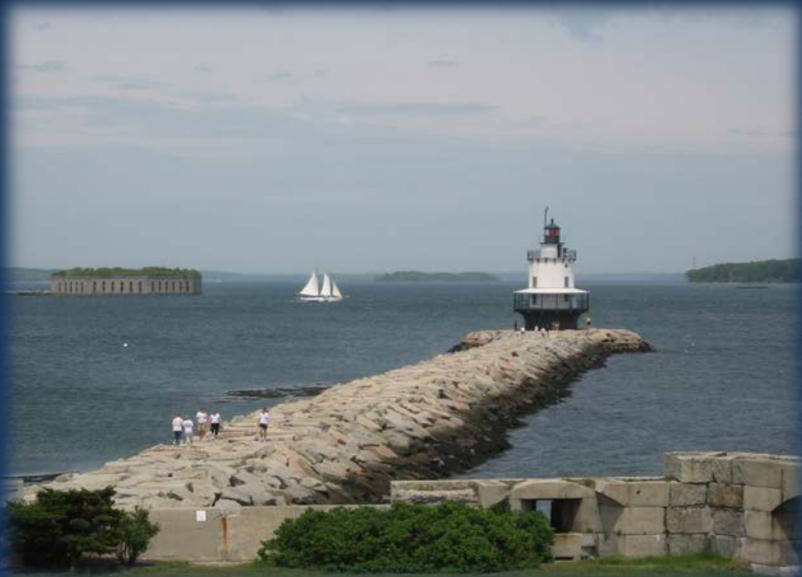
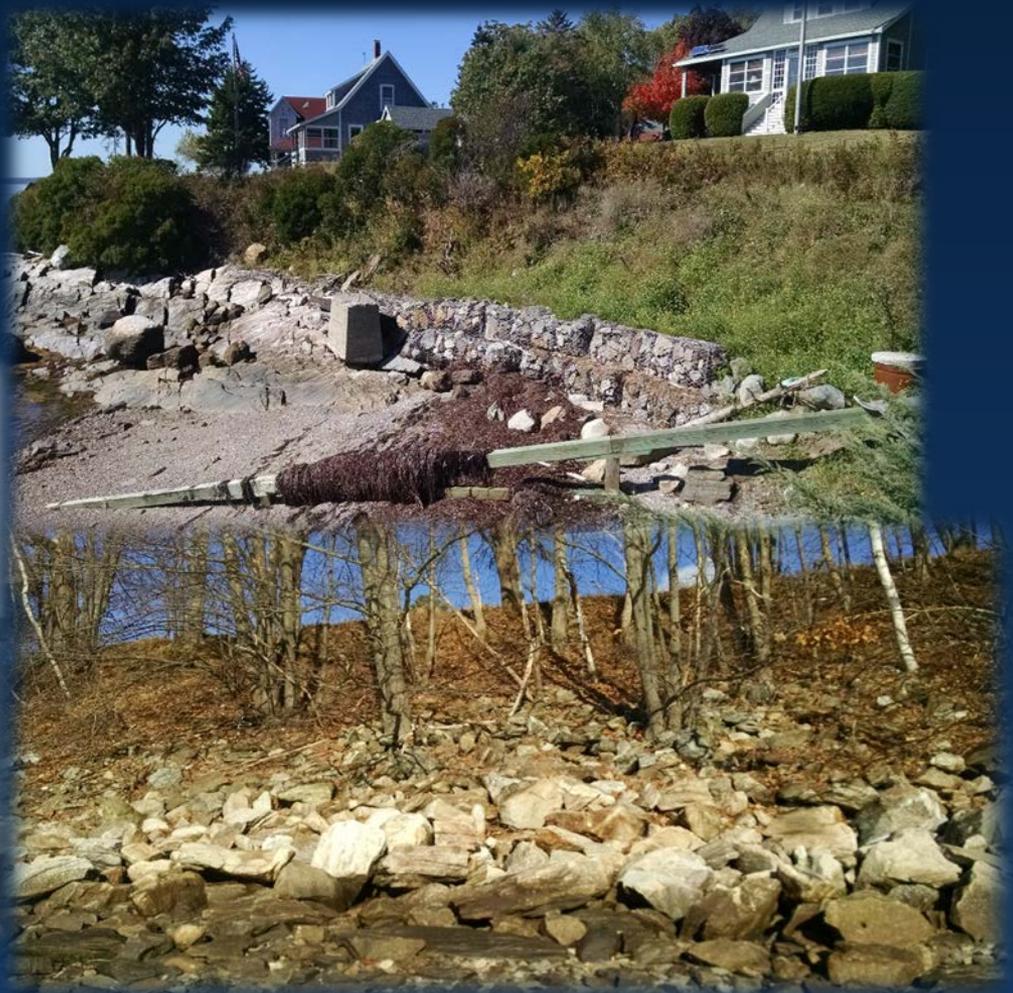
Traditional Stabilization Practices

- Riprap
- Bulkheads
- Jetties & Groins

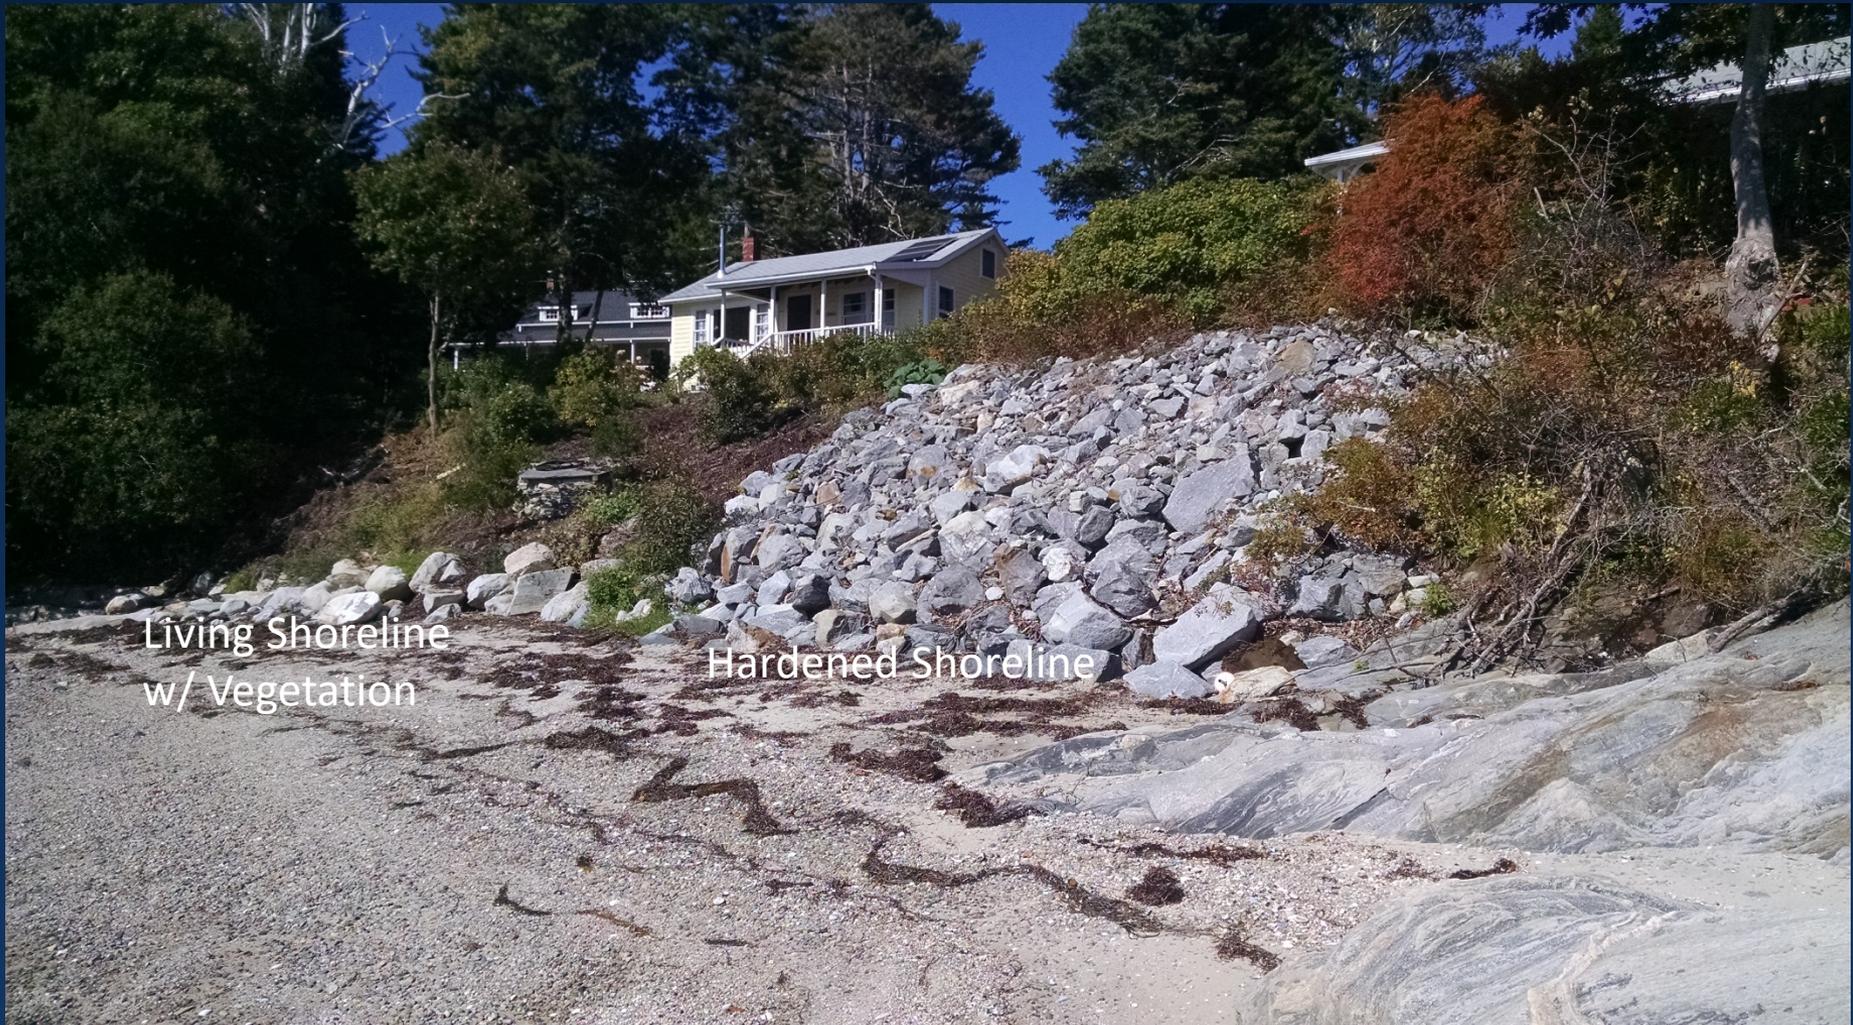
Vegetation vs Riprap

Living Shoreline
w/ Vegetation

Hardened Shoreline

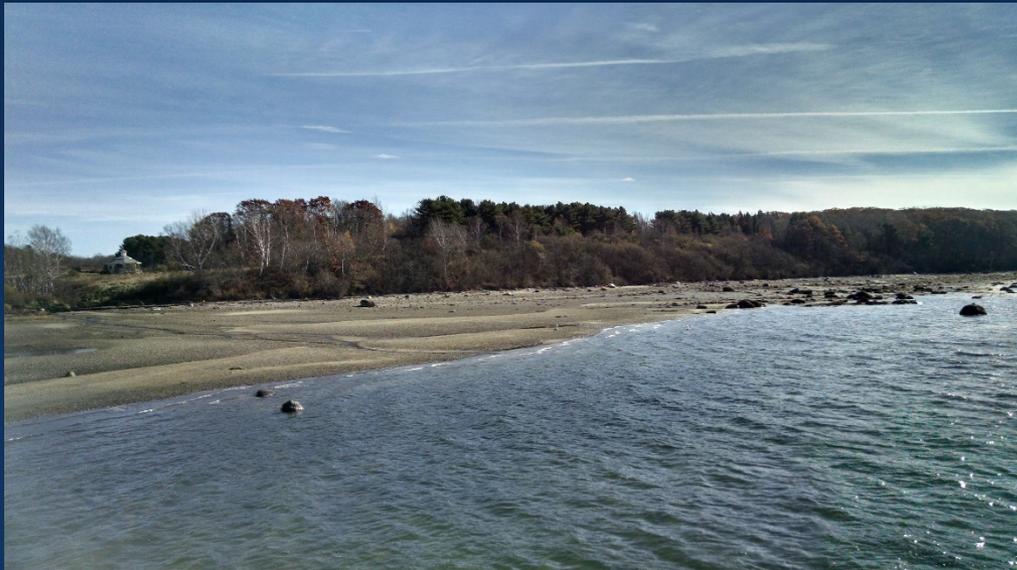
Bluff Resilience Case Study: Mitchell Field, Harpswell

- Analysis Sites
- Stable
- Unstable
- Highly Unstable
- 2 Foot Contours
- Minor Drainage
- Major Drainage
- Local Road

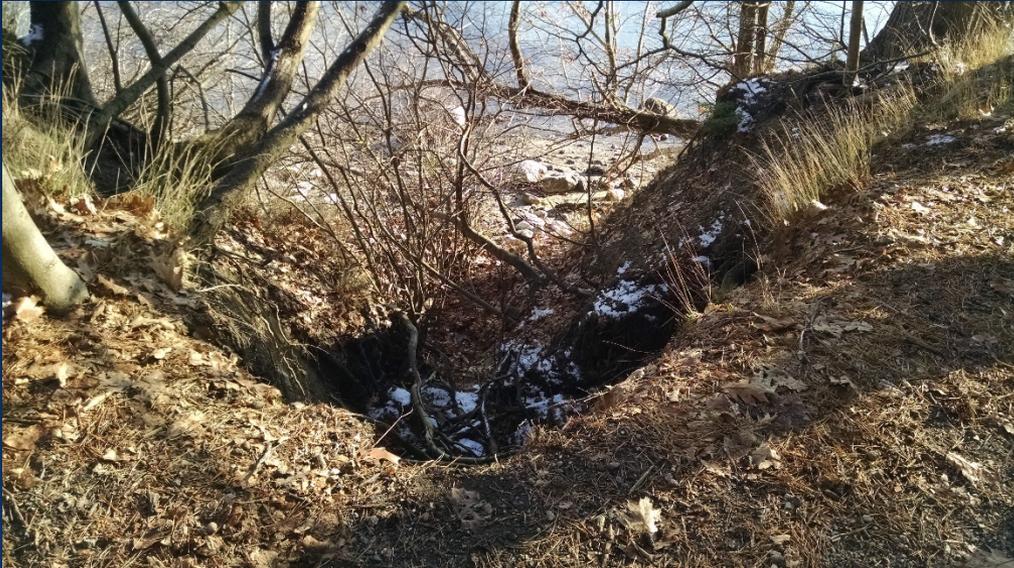
Bluff Resilience Case Study: Mackworth Island, Falmouth

- ▲ Mackworth Sites
- Stable
- Unstable
- High Unstable
- Minor Drainage
- Main Drainage
- Local Road
- Subdivided Acres

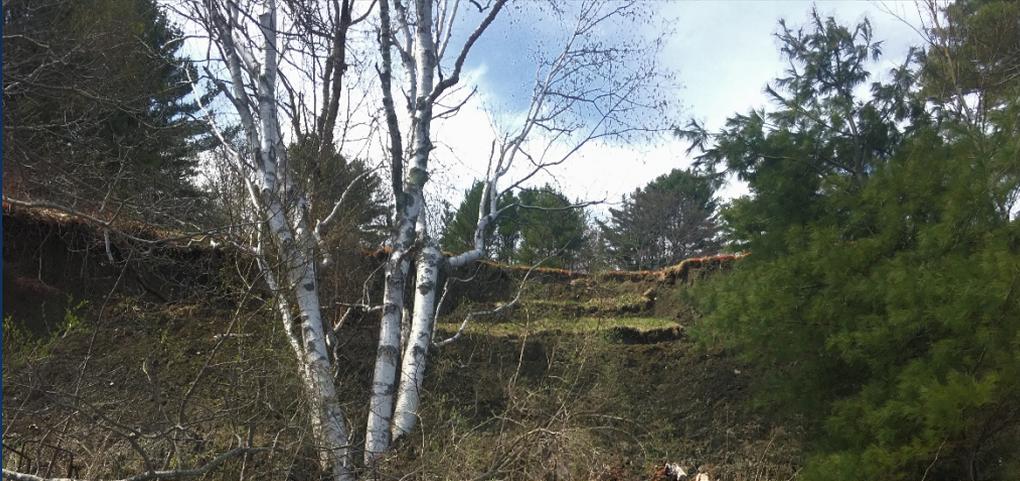
Bluff Assessment: 17 Webb Field Rd. Brunswick ME

- POI
- ▬ Bluffs
- ▬ Local Road
- ▬ Sheet flow - 1 Acre
- ▬ Minor (1-2 acres)
- ▬ Major (>2 acres)
- ▬ Flats
- ▬ Contours (ft)

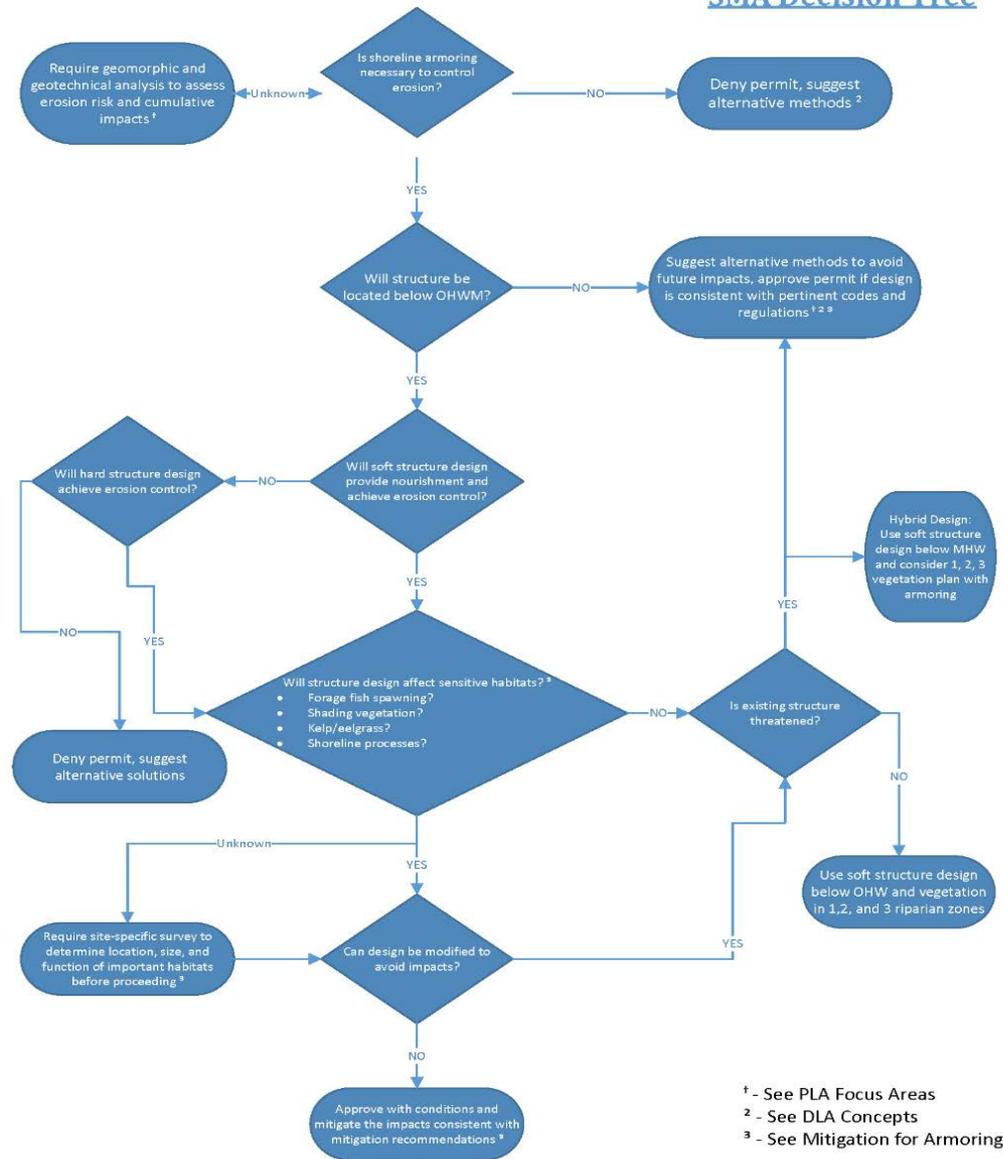
SMA Decision Tree

† - See PLA Focus Areas
 ² - See DLA Concepts
 ³ - See Mitigation for Armoring
